# Environmental and Social Management Plan

Rehabilitation/Reinforcement of 7No. Transmission Substations  
(PACKAGE 2 LOT 2): 330/132/33kV T/S at Osogbo (Osun State),  
Delta IV (Delta State), Benin (Edo State)

132/33kV T/S at Ilorin (Kwara State), Ondo (Ondo State), Irrua  
(Edo State), and Effurun (Delta State), respectively.

October, 2019.

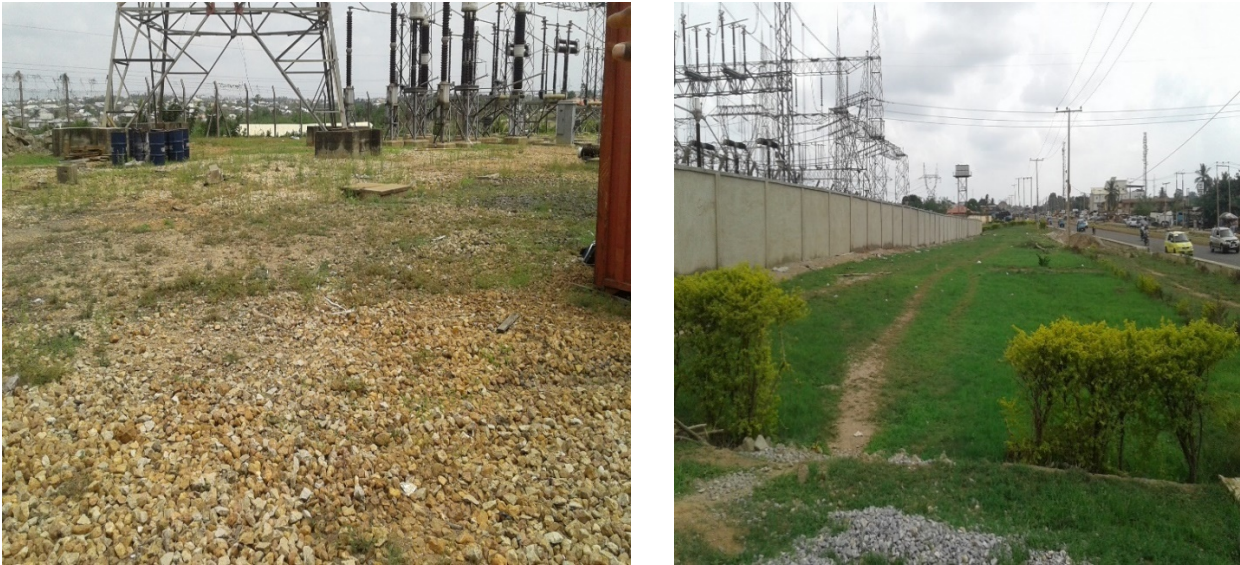
**Figure 9: Weed overgrowths within the switchyard/Weed overgrowths within the switchyard.**

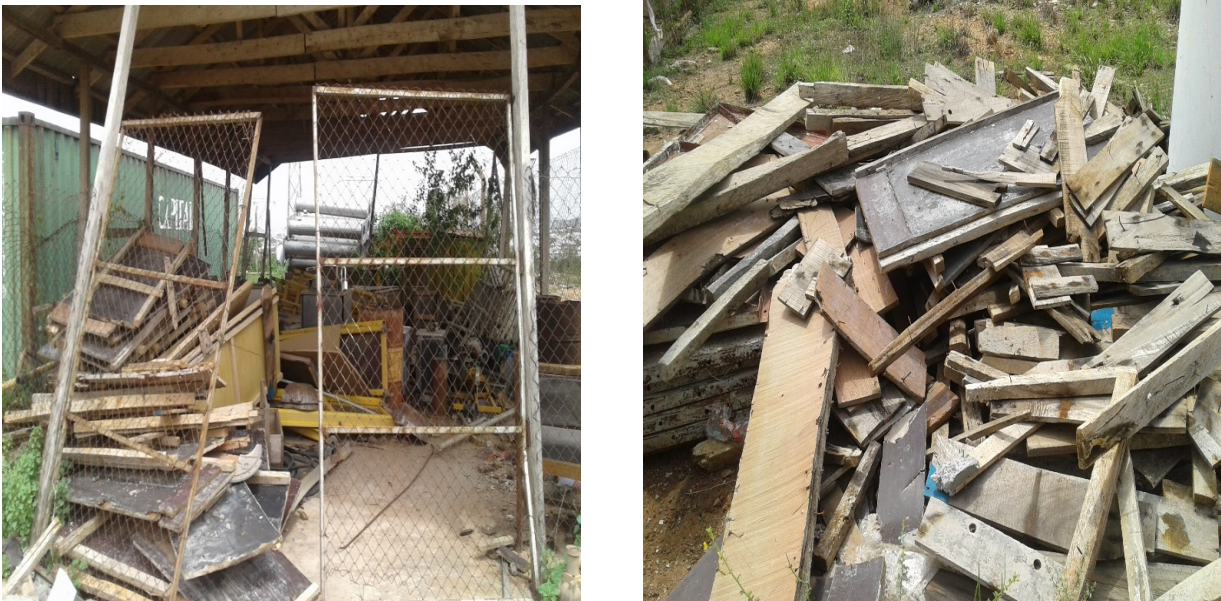
**Figure 10: Temporary designated Junkyard / Scrap generated from on-going construction works.**

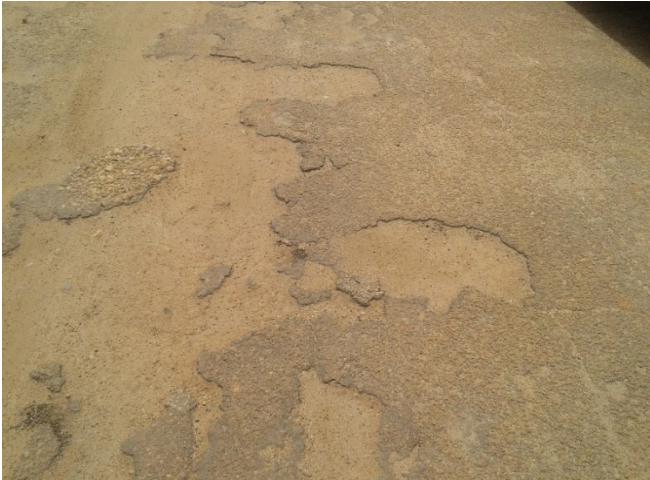
The drive-way within the substation premises in a very bad condition and require rehabilitation.

**Figure 11: Drive-way within the substation in a bad state.**

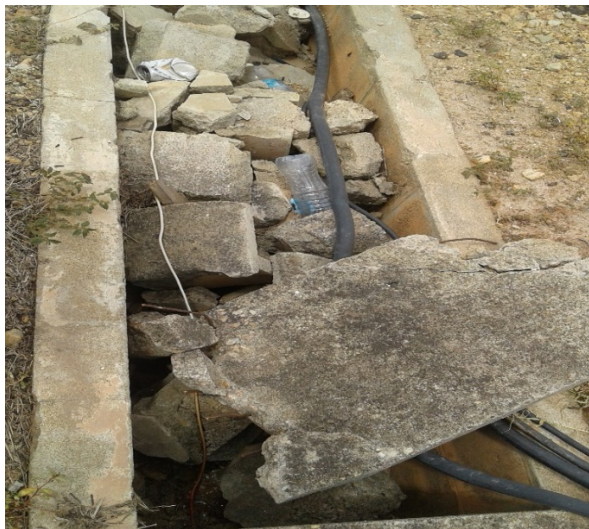
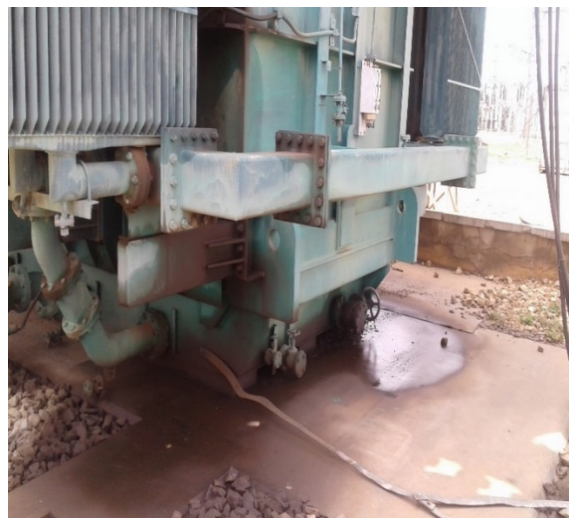
**Figure 12:Blocked drainage channels/Transformer base showing signs of slight oil leakage.**

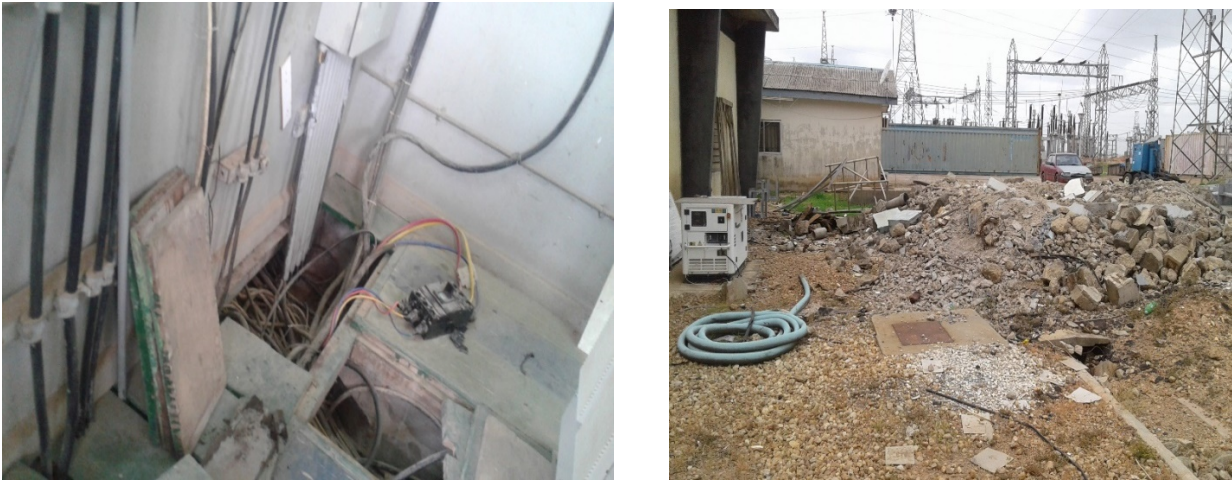
Some of the cable trench slabs covers within the control rooms are either broken or out of place.

**Figure 13: Exposed cable trenches within the Control room/Debris of demolished building**

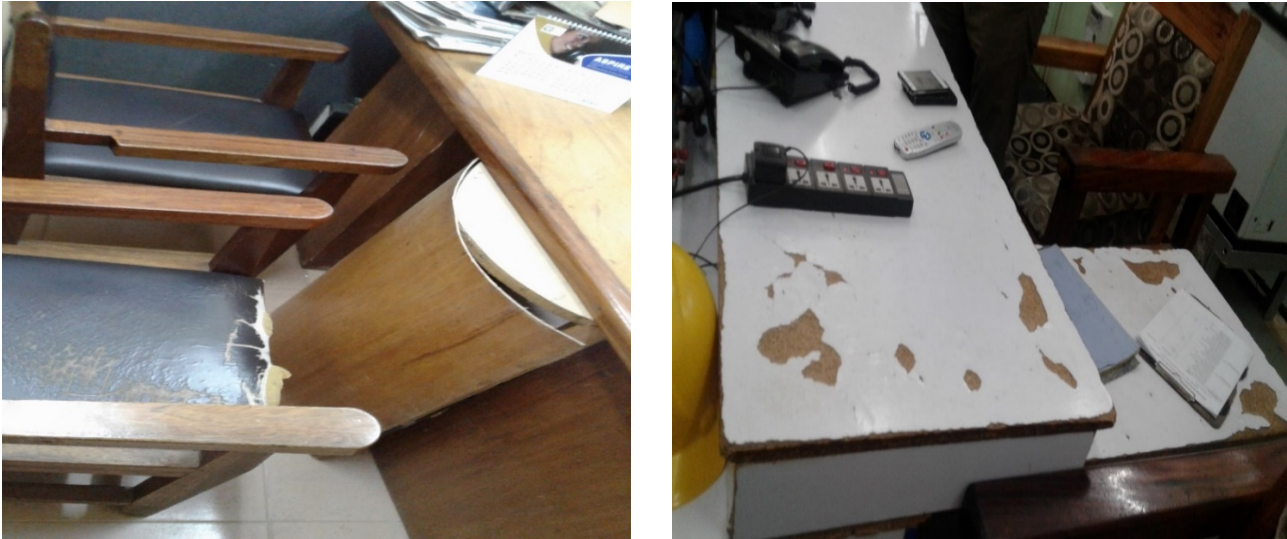
**Figure 14: Bad office furniture available for use by operators /Decaying work table in use by Operators**

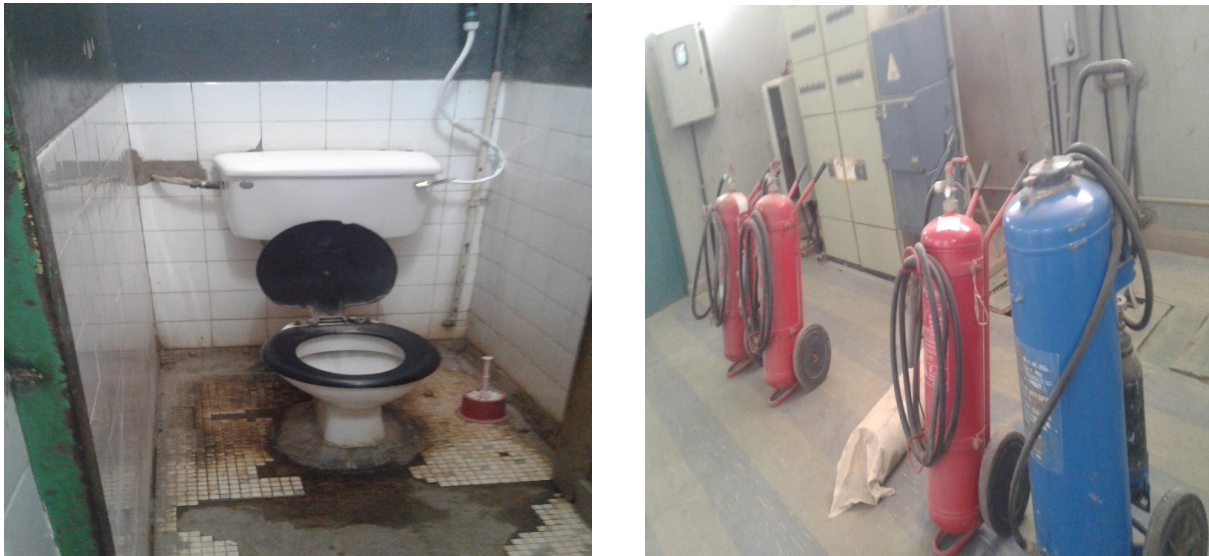
**Figure 15: Restroom used by operators in poor hygienic condition / Serviced fire extinguishers**

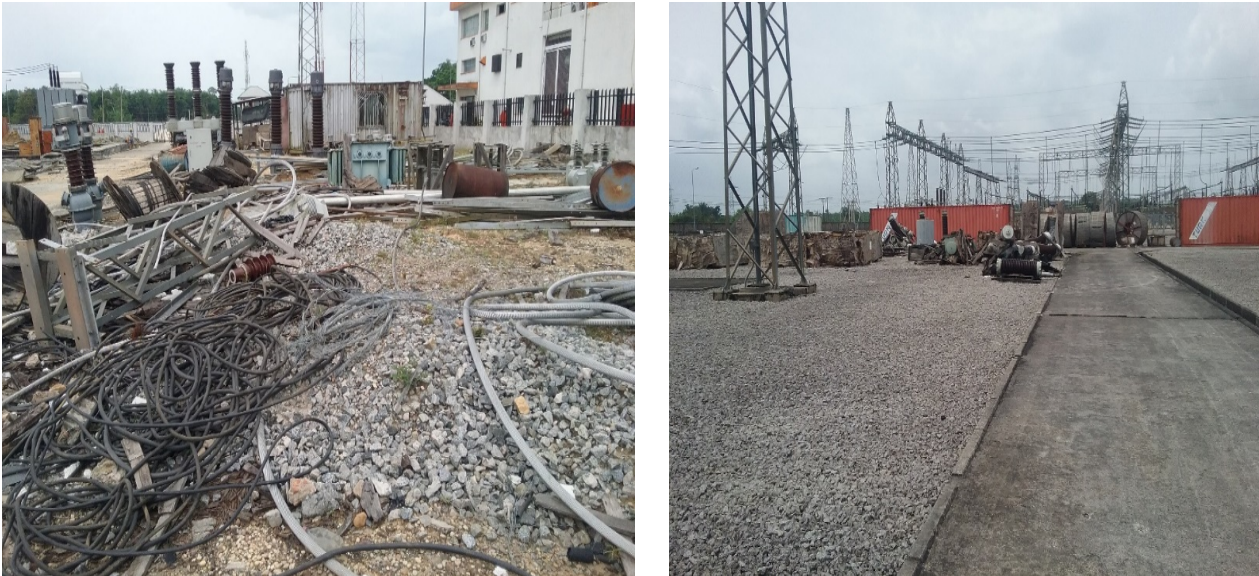
**Figure 17: Improperly disposed waste materials/Decommissioned equipment/materials littering the Substation premise.**

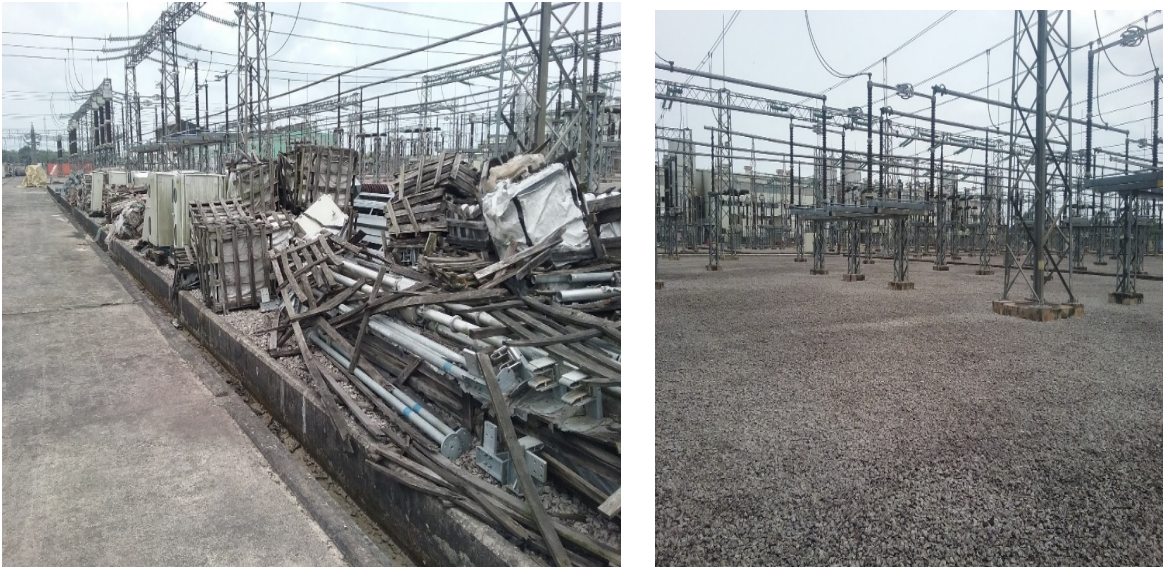
**Figure 18: Abandoned unused installation materials/Properly maintained Switchyard floor.**

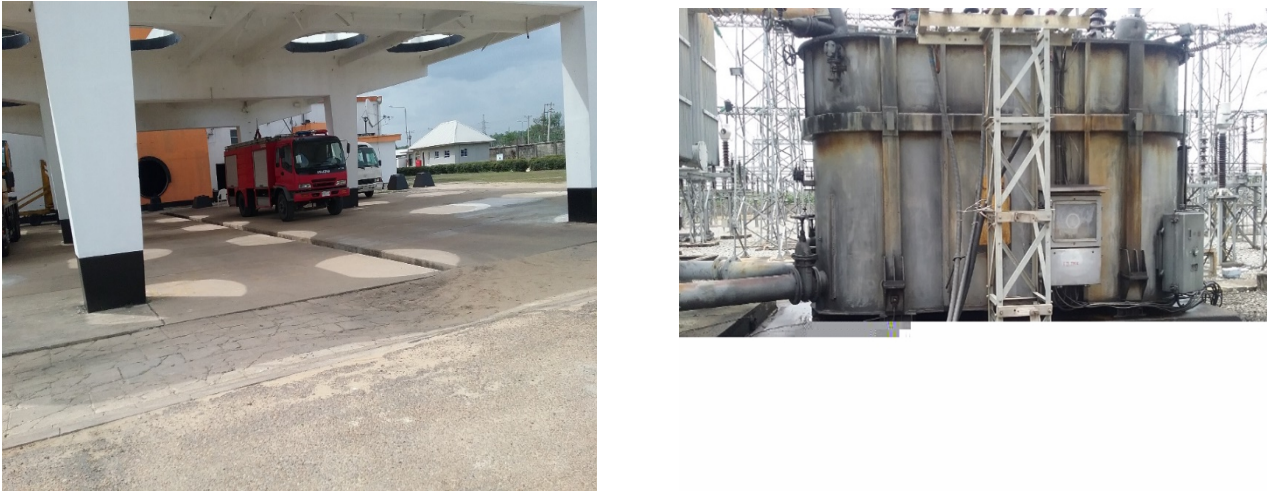
**Figure 20: Standard standby fire-fighting truck within the substation premise. /Spilled oil from an old .**

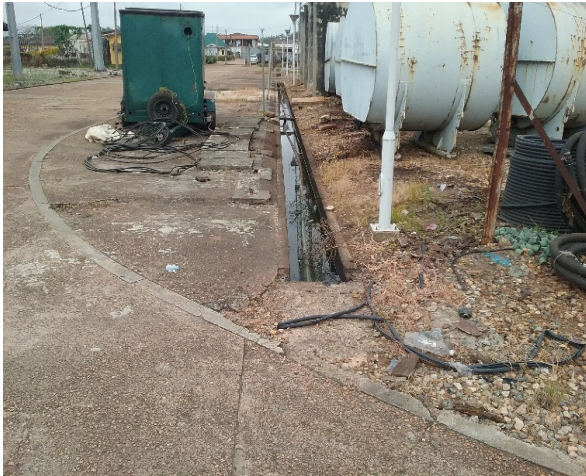
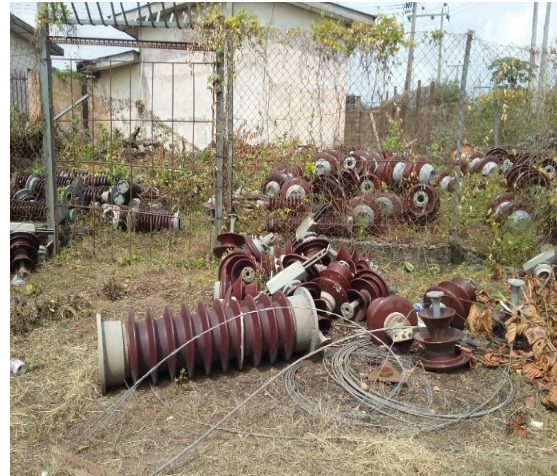
**Figure 22: Decommissioned equipment littering the Substation premises/Recovered transformer**

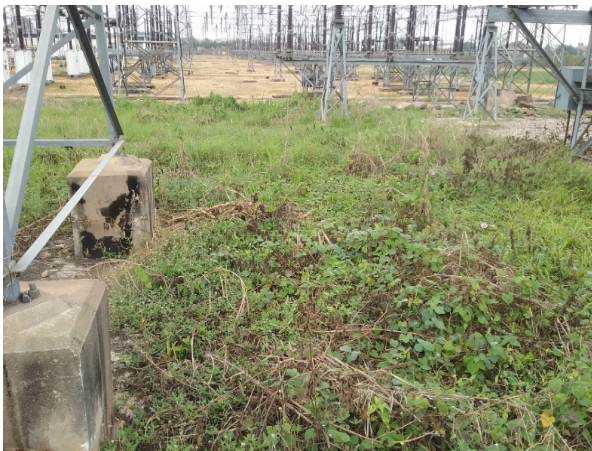
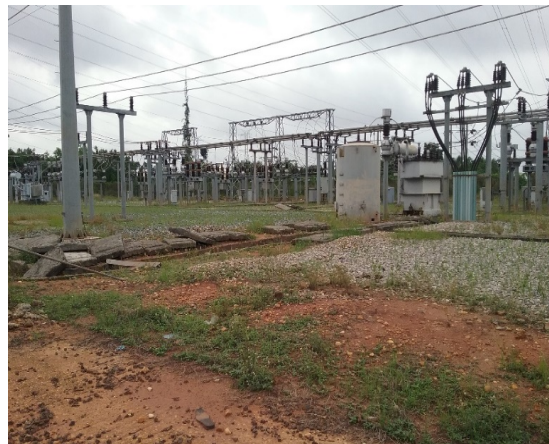
Weeds can be seen growing on the Switchyard floor (which is not adequately graveled) and this situation could get out of Control when the rains set in.

**Figure 23: Overgrown weeds have taken over part of the Switchyard floor/Part of Switchyard floor with scanty gravelling.**

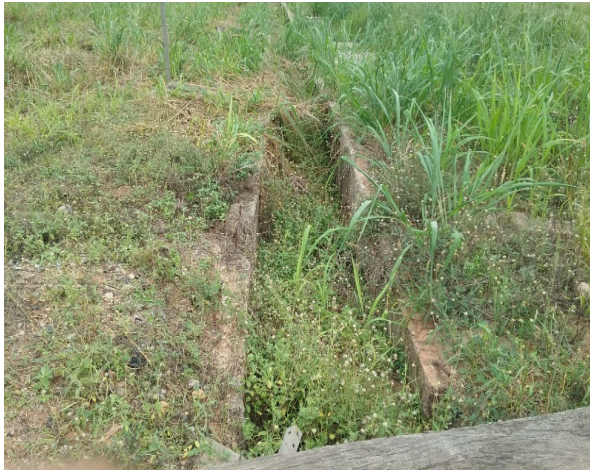
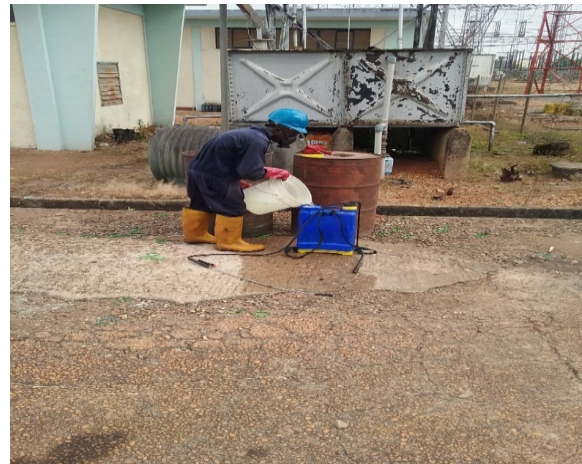
**Figure 24: Blocked drainage channel completely overtaken by overgrowths/Strict adherence to use of PPEs during application of weed control chemical fumigation.**

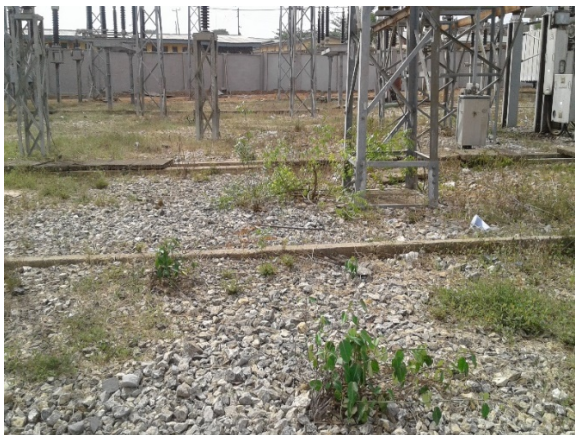
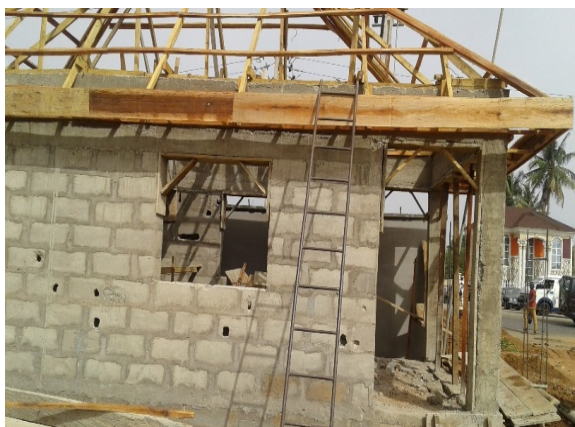
**Figure 27: Weed overgrowths within the switchyard/On-going civil works (construction of a new security post).**

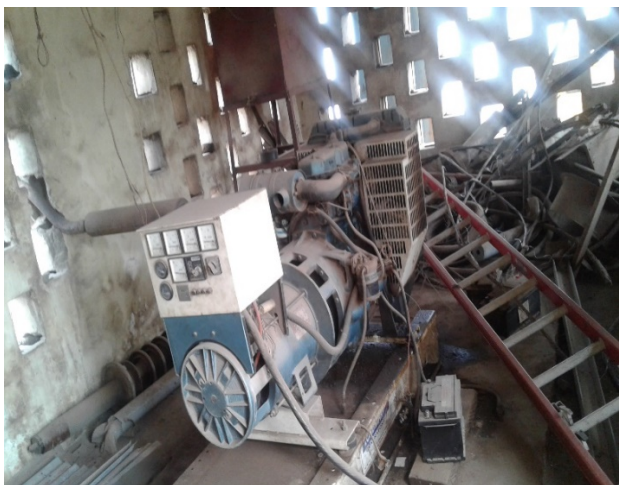
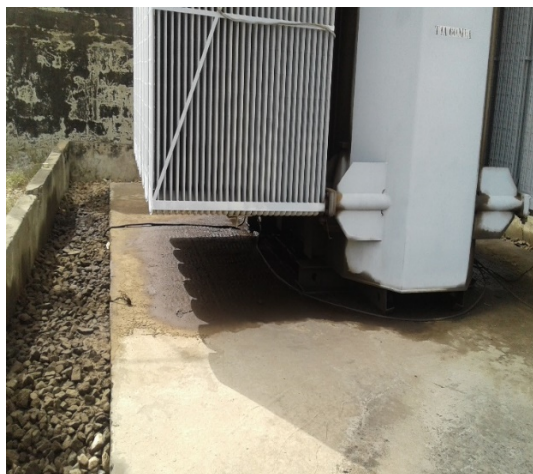
The substation switchyard floor is almost completely covered with weed overgrowths and is poorly maintained.

**Figure 28: Antiquated generator in use at the Substation (source of noise and air pollution)/Transformer base showing signs of oil leakages.**

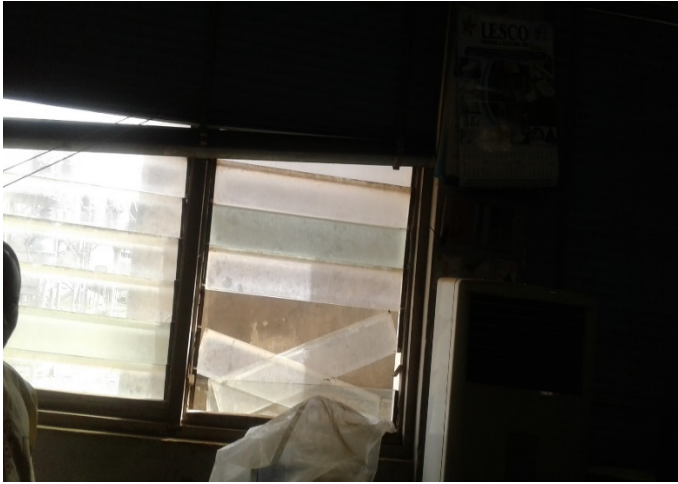
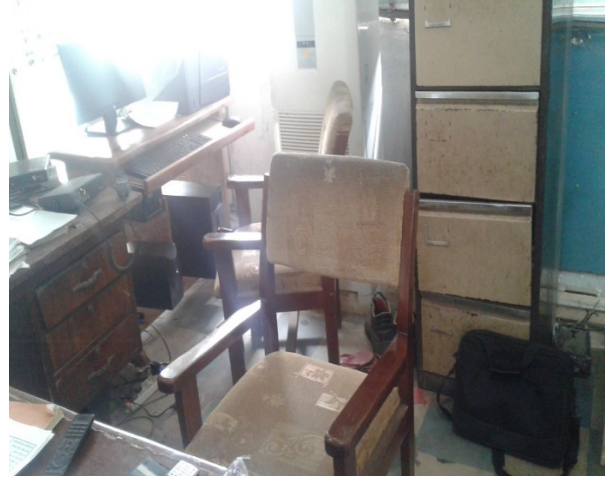
Some of the cable covers trench slabs within the control rooms are either broken or out of place.

**Figure 29: Broken louvre panes and bad office furniture within the control room.**

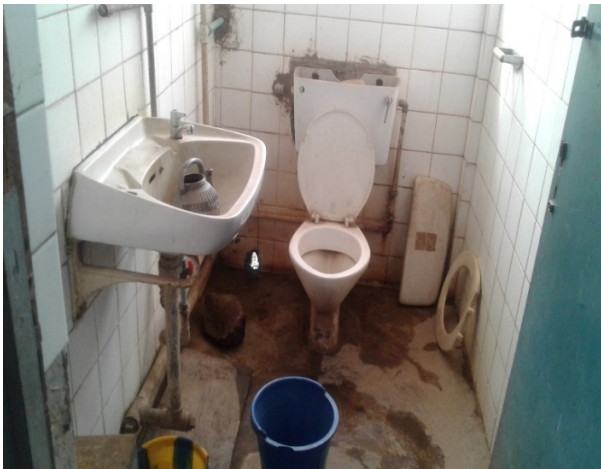
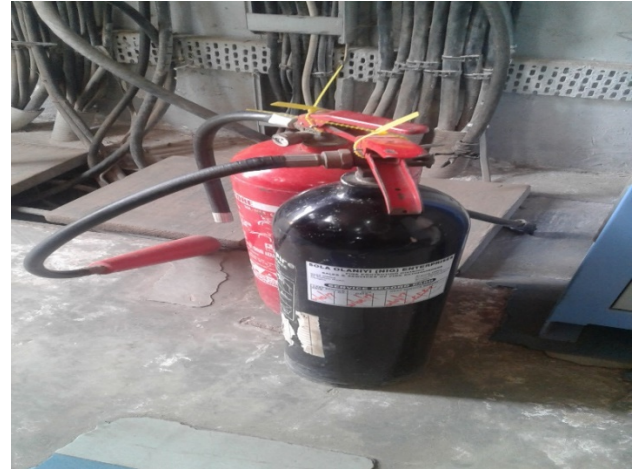
**Figure 30: Deplorable state of toilet facilities/ Serviced fire extinguishers ready for deployment in the event of fire outbreak.**

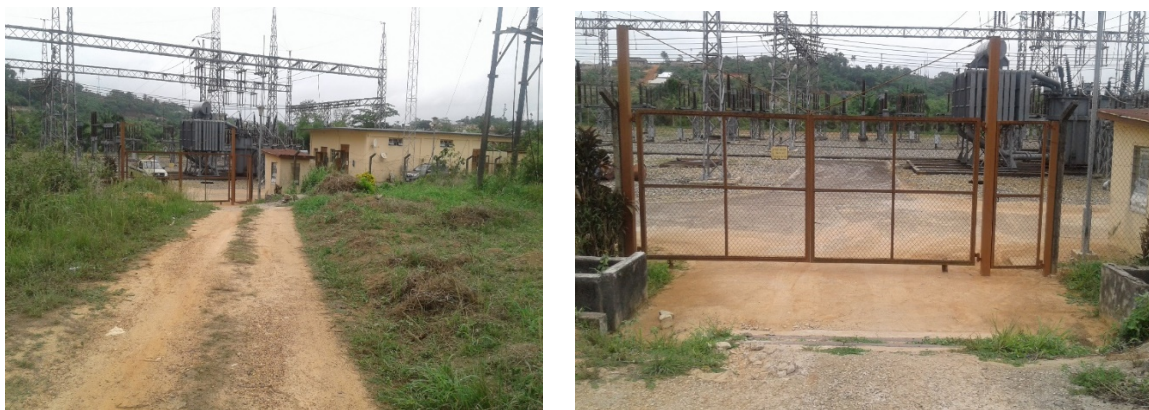
The Access road leading to the Substation is clearly defined and free of encumbrances but untarred.

**Figure 31: Approach to the substation entrance/Rusty and weak looking entrance gate Securing the substation.**

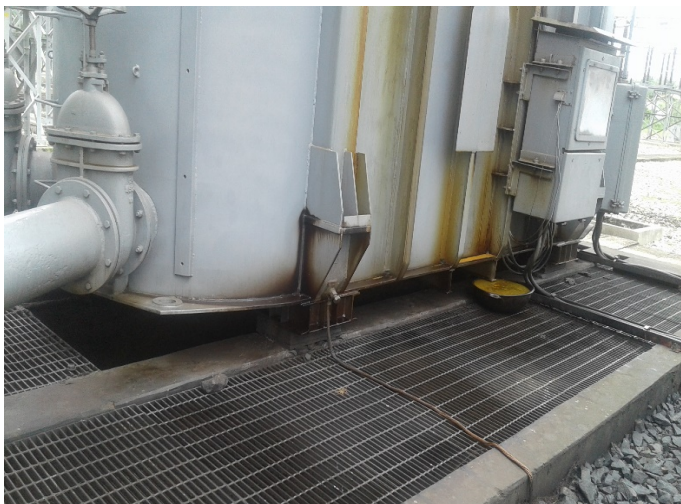
**Figure 32: Transformer base showing signs of oil leakage.**

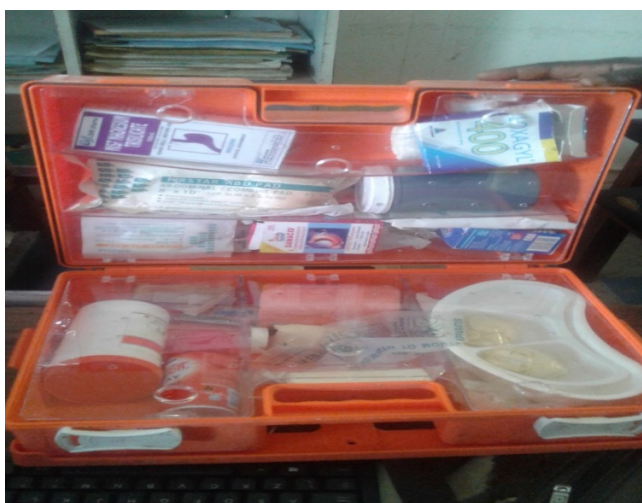
The building structure of the control room which also serve as office space for the Operators is in very poor condition due to age and inadequate maintenance; poor ventilation, poor illumination, damaged furniture and poor state of toilet facility.

**Figure 33: Sparse First Aid kits in the First Aid available for use by operators.**

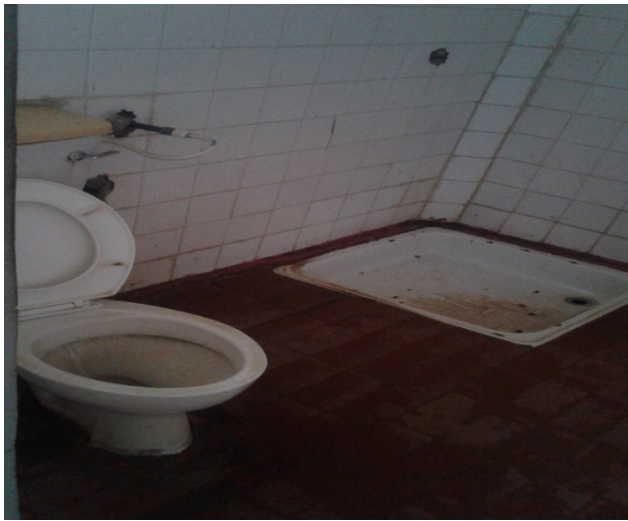
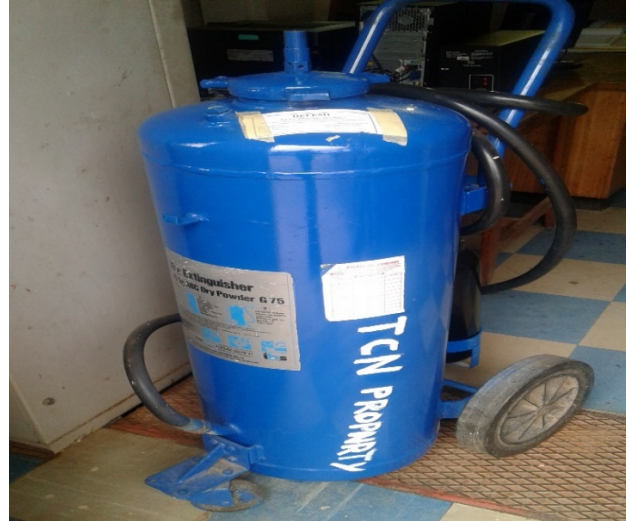
**Figure 34: Restroom used by operators in a state of poor hygiene/ Serviced fire extinguishers ready for deployment in the event of fire outbreak.**

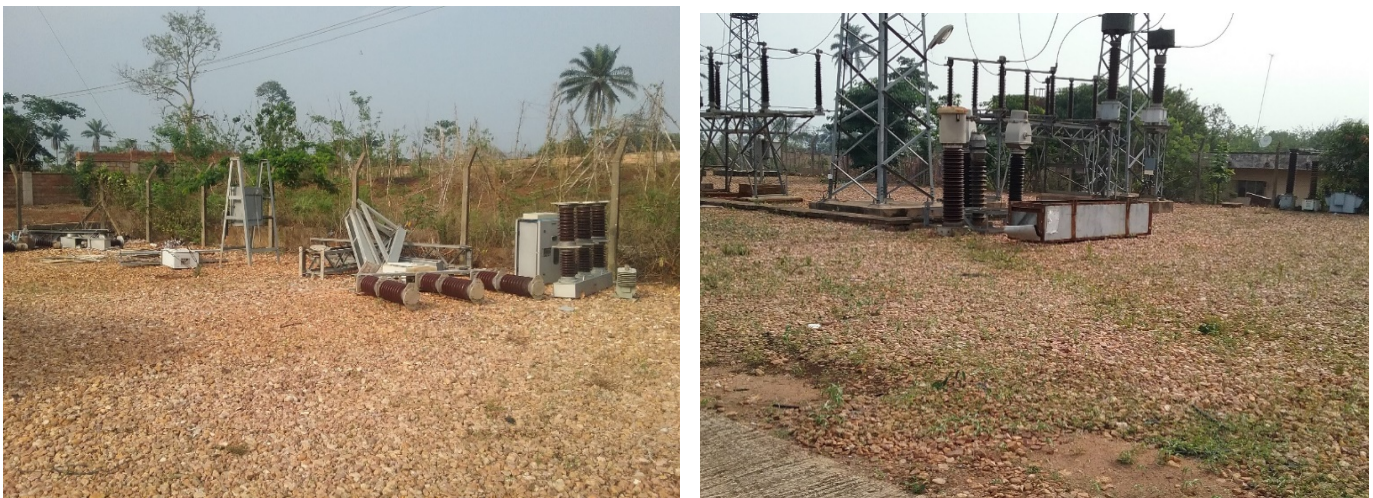
**Figure 35: Scraps littering the Substation premise/ scantily graveled switchyard floor (with patches of light overgrowths).**

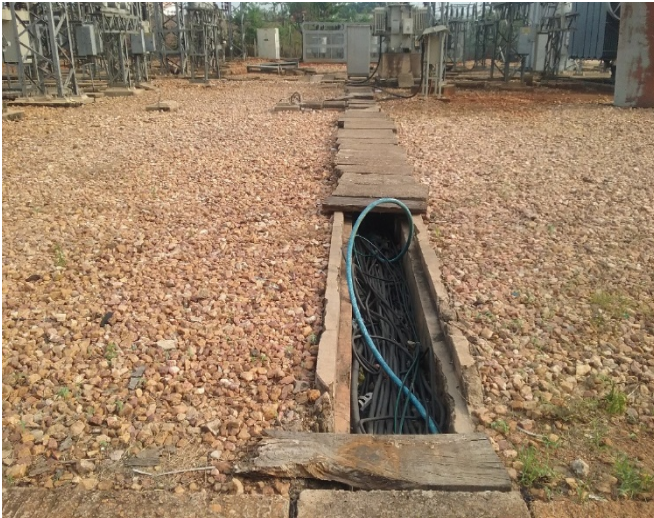
Some of the Cable trench cover slabs are broken (or missing completely) thereby leaving current-carrying cables hazardously exposed and susceptible to damage or harm to people.

**Figure 36: Missing cable trench slabs.**

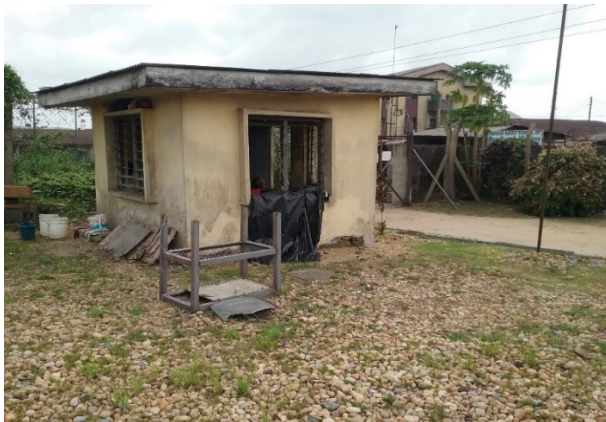
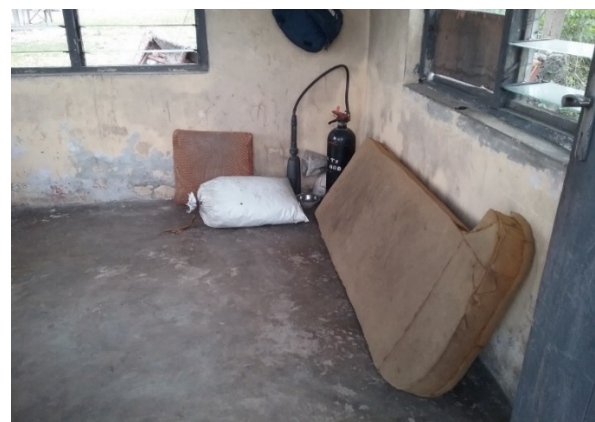
**Figure 37: Decrepit building structure/ Very poor furnishing in the Substation Security post.**

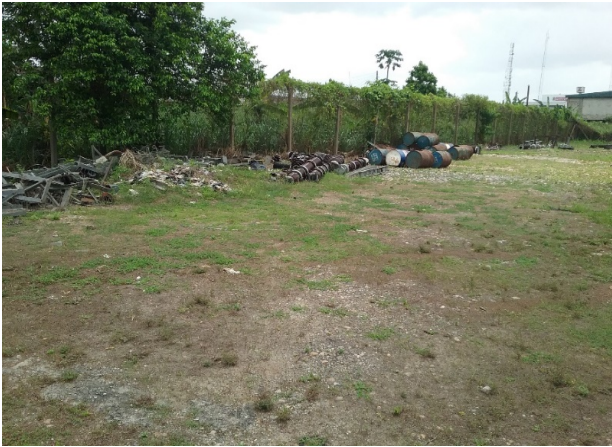
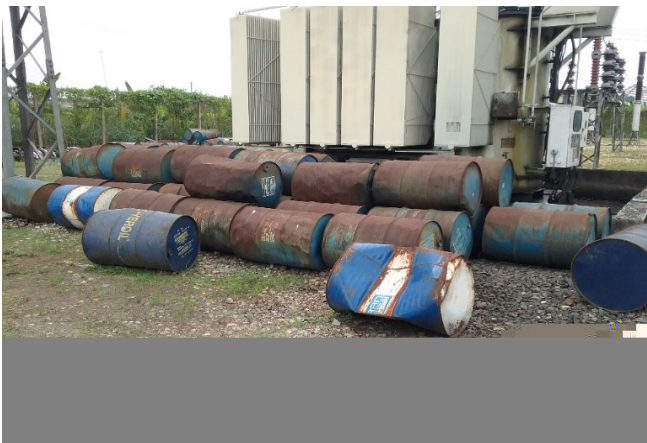
**Figure 38: Transformer Oil drums, decommissioned equipment/materials littering the Substation premises**

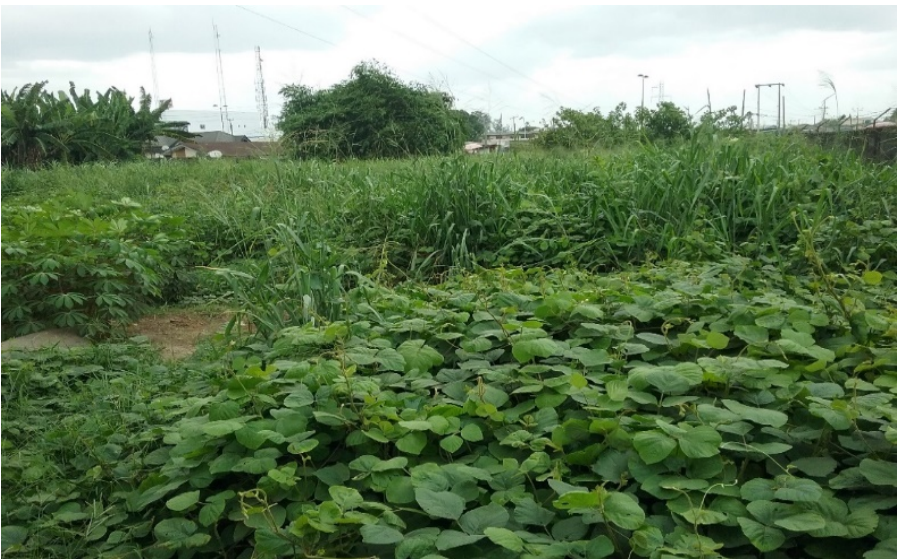
**Figure 39: Overgrown weeds have taken over significant part of the Substation premise.**

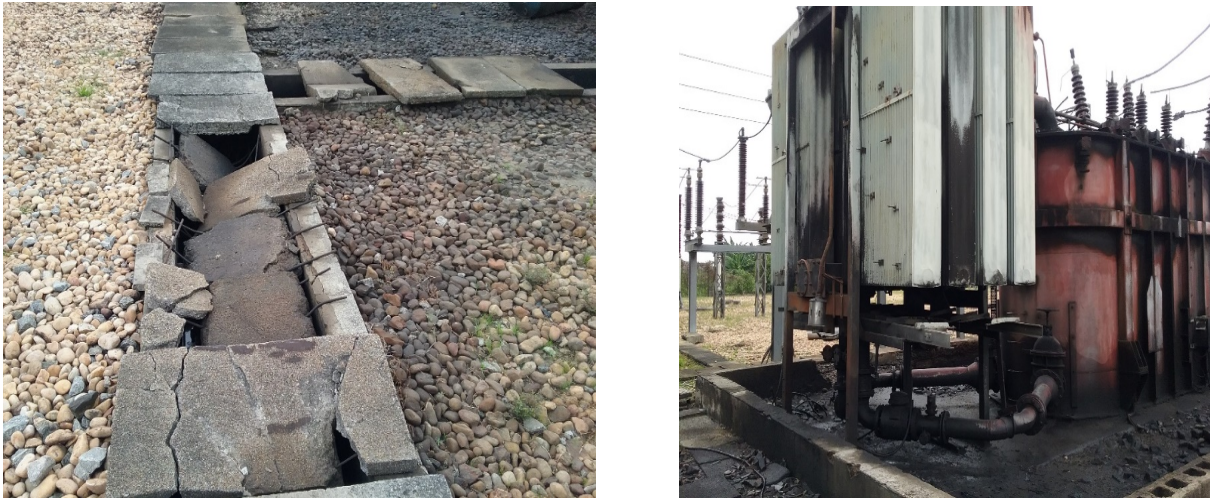
**Figure 40: Broken/Collapsed trench slabs and Spilled oil from very old transformer within switchyard.**
