Environmental and Social Management Plan (ESMP)

Rehabilitation/Reinforcement of 13No. Transmission Substations
(PACKAGE 2 LOT 1):

The proposed Nigeria Electricity Transmission Project
(NETAP).

Transmission Company of Nigeria (TCN)

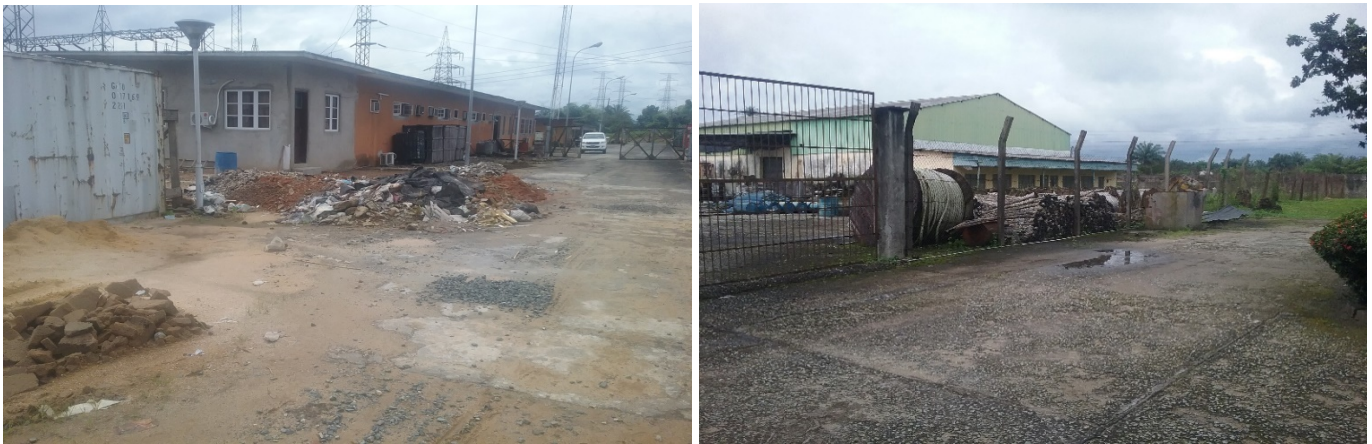
Figure 15: Extension works on-going on existing Control Room building /Well defined and fenced storage area the substation premise.

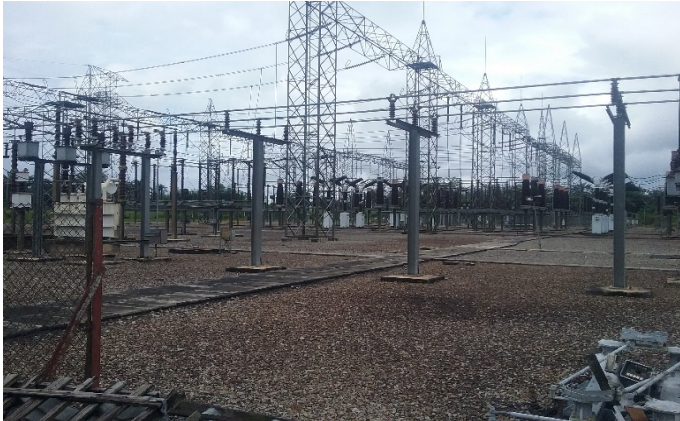
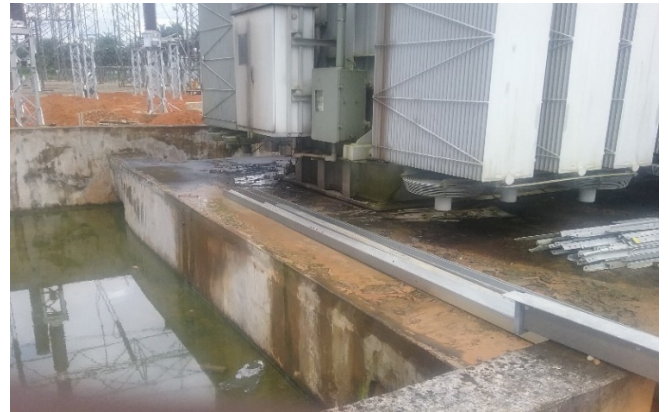
Figure 16: Properly maintained switchyard floor/Stagnated water body at base of transformer.

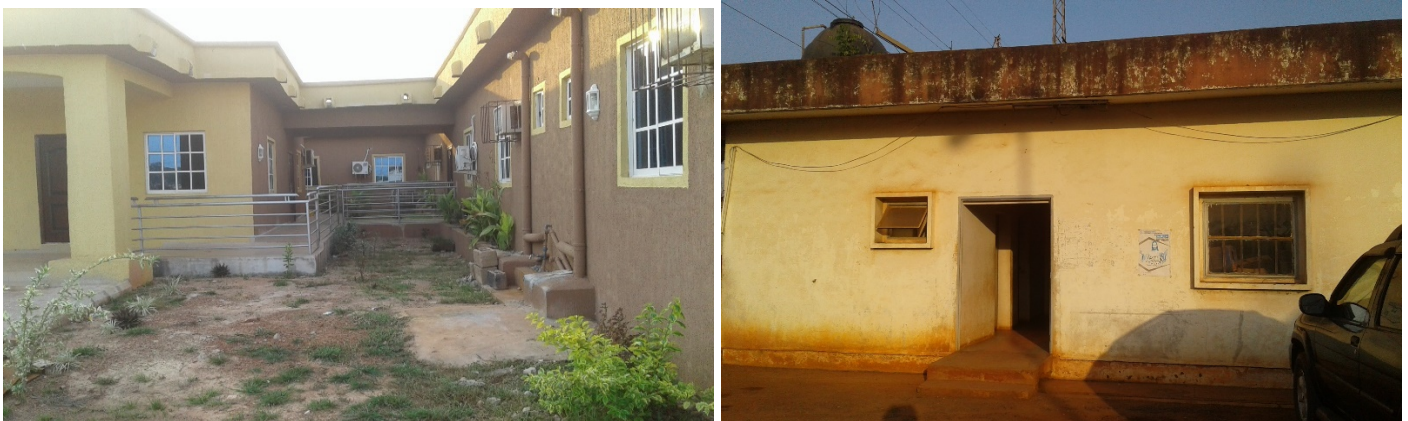
The building structures in the Substation are very old and require refurbishing and proper maintenance.

Figure 17: Substation Administrative building/Existing Control Room building.

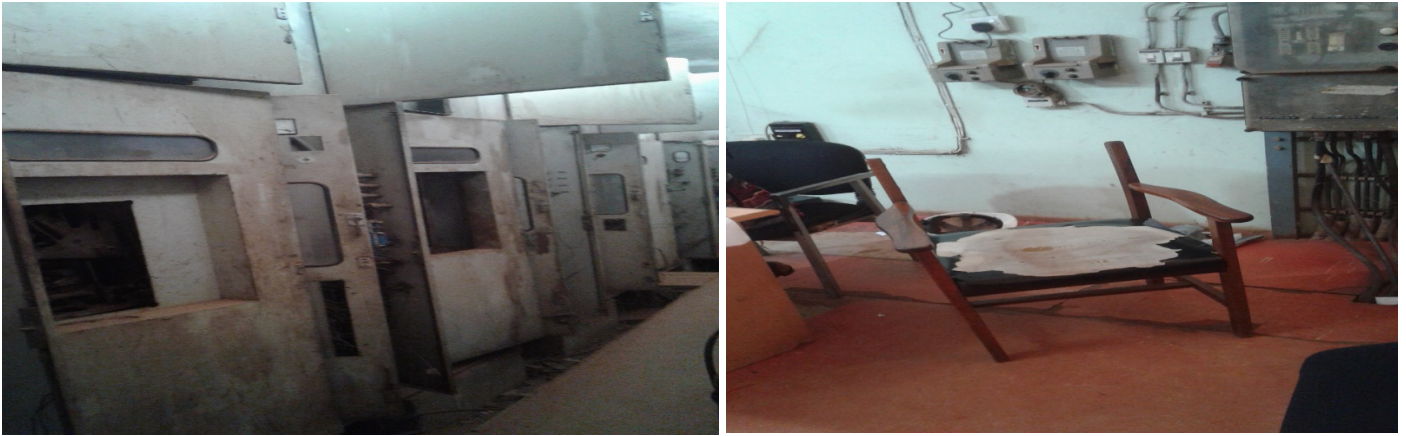
Figure 18: Old control Panels in Control room (ready for decommissioning)/Decrepit furniture being use by operators.

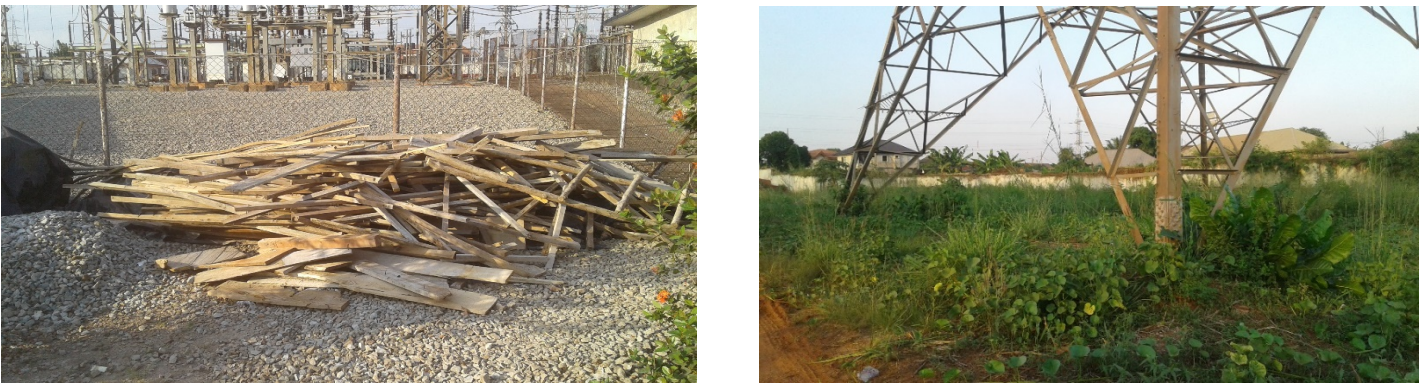
Weeds can be seen growing on the Switchyard floor (which is not adequately graveled) and this situation could get out of Control when the rains set in.

Figure 19: : Improperly disposed construction waste/Overgrowths within substation premise.

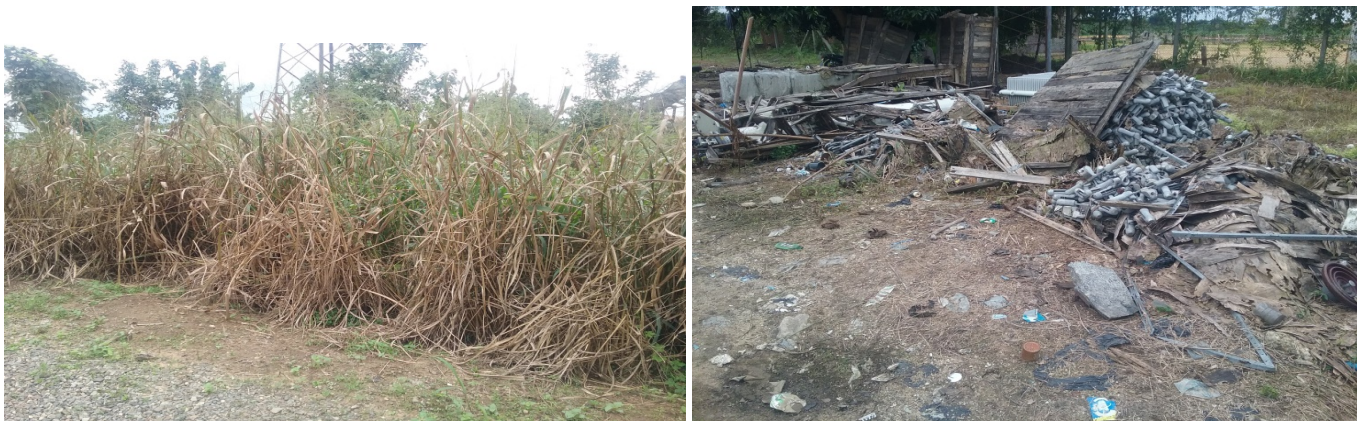
Figure 20: Dense Overgrowths within the Substation premise/Indiscriminate waste disposal within the substation.

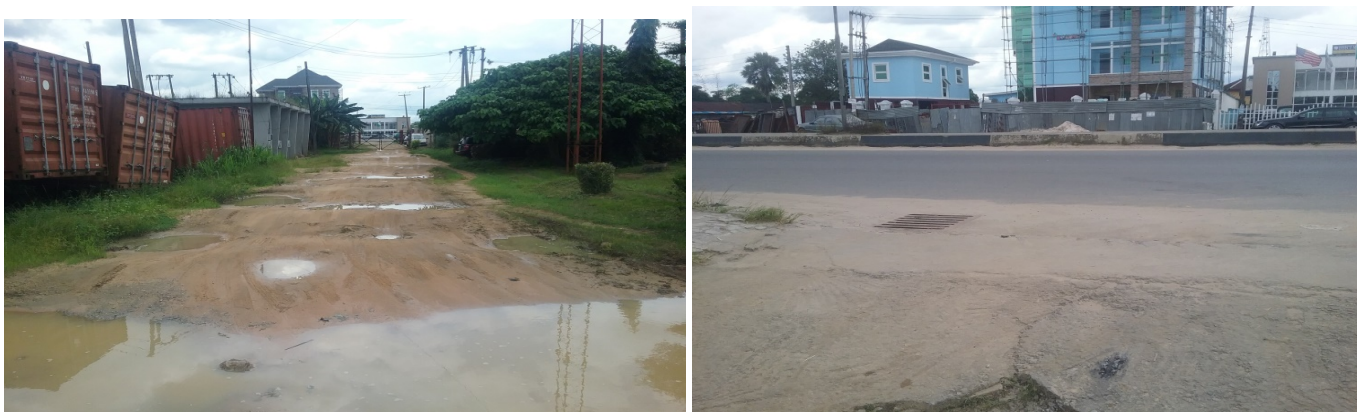
The access road leading to the Substation is clearly defined, tarred and free of encumbrances. However, the drive path within the substation premise is dilapidated and in dire need of rehabilitation.

Figure 21: Drive path within Substation premise/Rumuobiokani Road (leading to the Substation entrance).

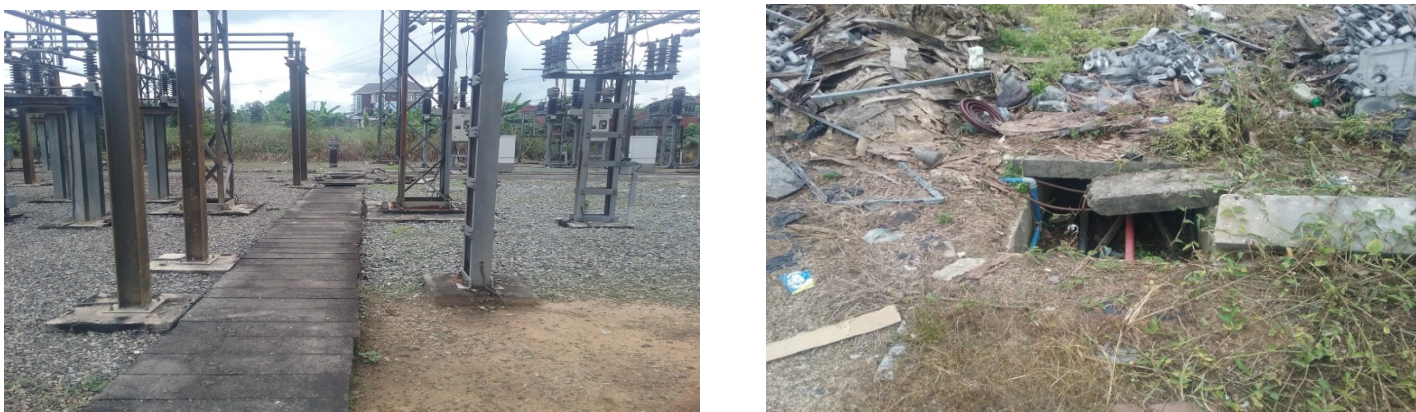
The substation switchyard floor is almost bare of gravel, however, it is properly maintained and kept free of weed overgrowths.

Figure 21: Sparsely graveled switchyard floor (with patches of light overgrowths)/ Exposed drainage cable trench.

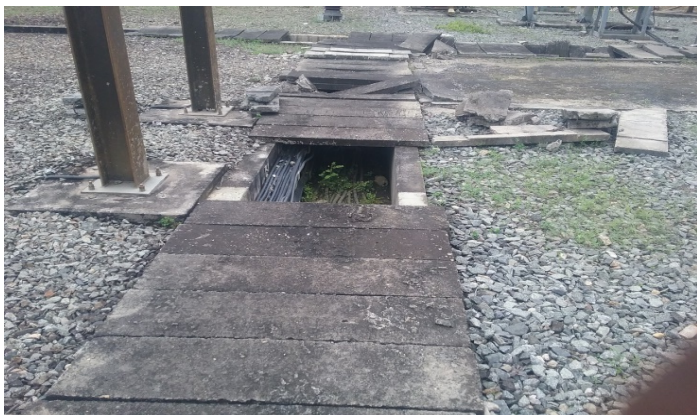
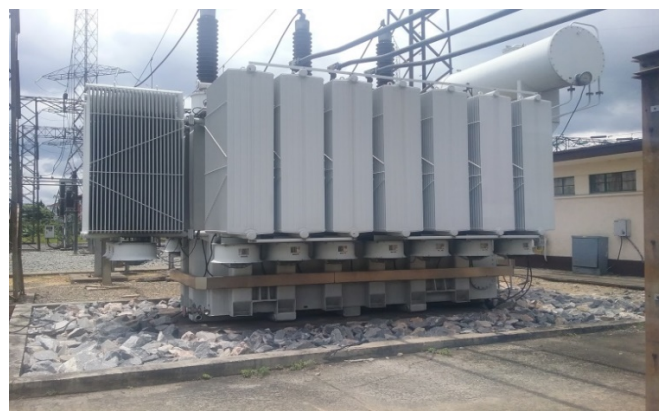
Figure 22: Weed growth in drainage channel/Oil Spill-free transformer base.

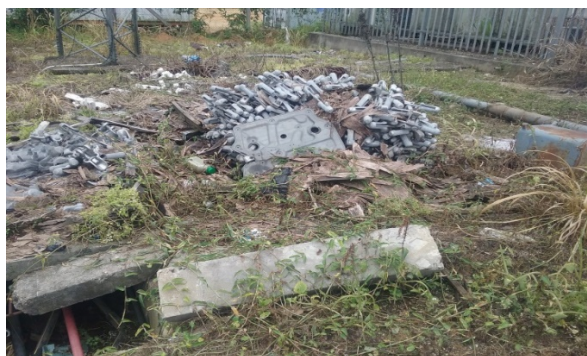
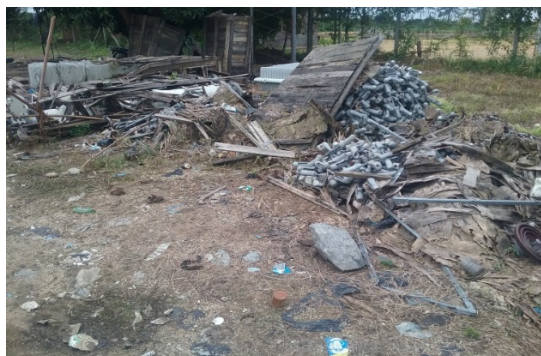
Figure 23: Improperly stored accessories strewn on the Substation premise/Indiscriminate waste disposal within the Substation premise.

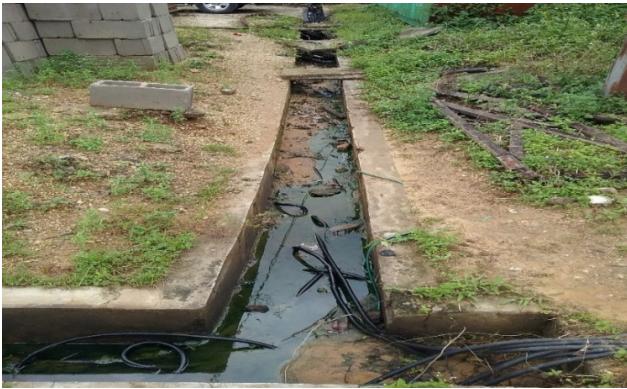
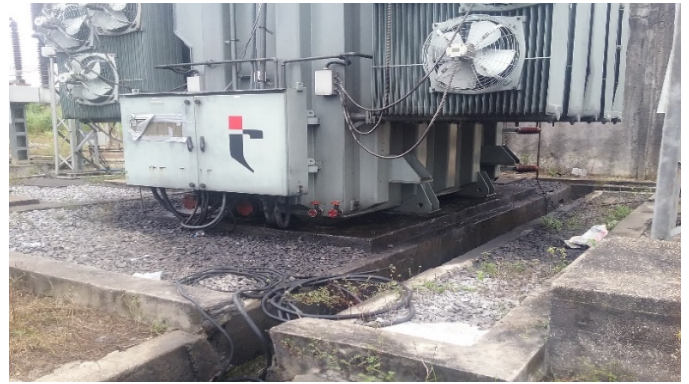
Figure 26: Blocked drainage channel resulting from sedimentation/Spilled oil at base of transformer.

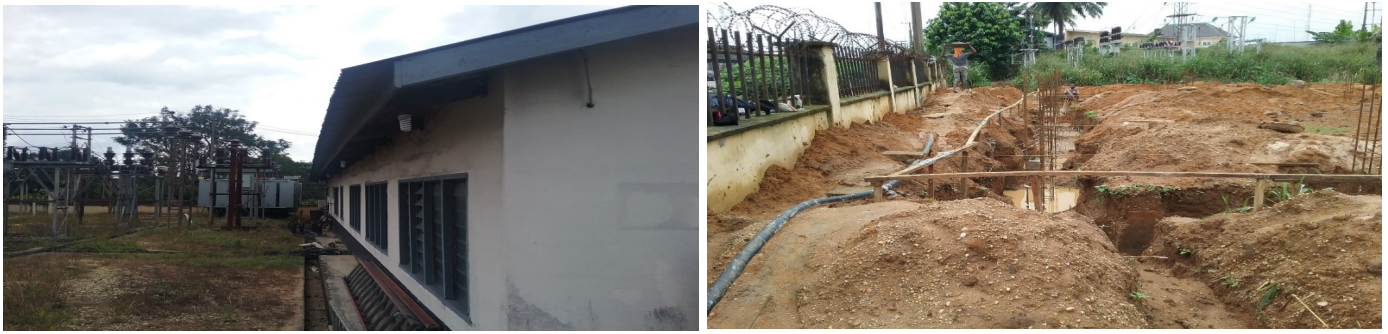
The Control room space is rather choked as there is barely enough working space for System operators, however there is an on-going construction of a new Control room under NEGIP.

Figure 28: Existing Substation Control Room/ Foundation for new Control Room (under NEGIP).

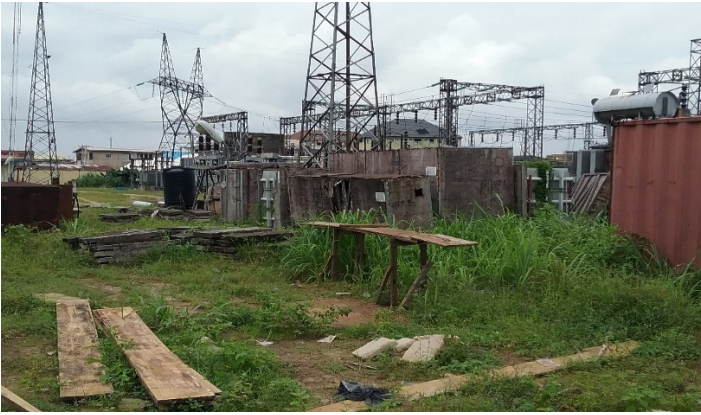
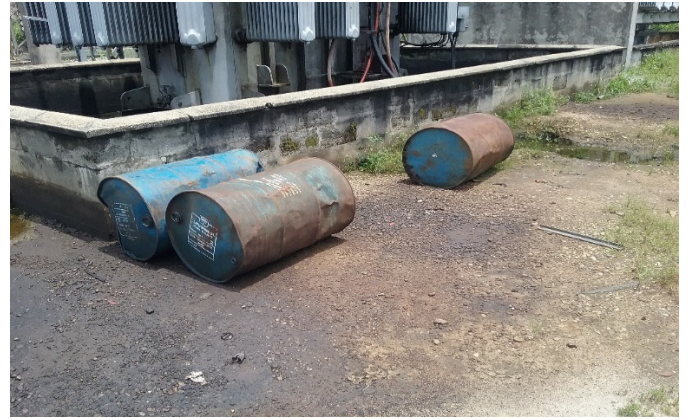
Figure 32: Overgrowths within the Substation premise/Improperly stored transformer oil drums.

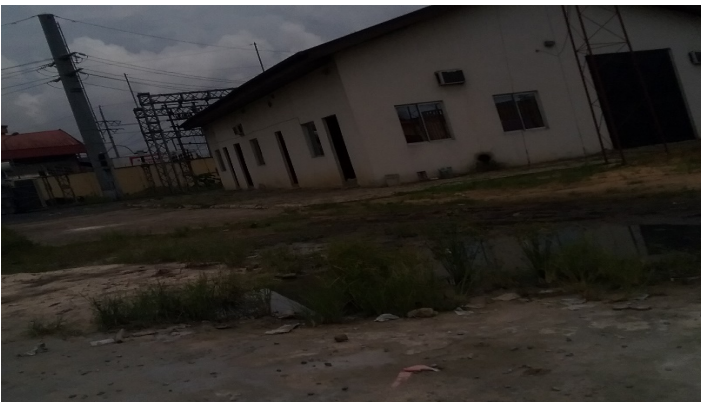
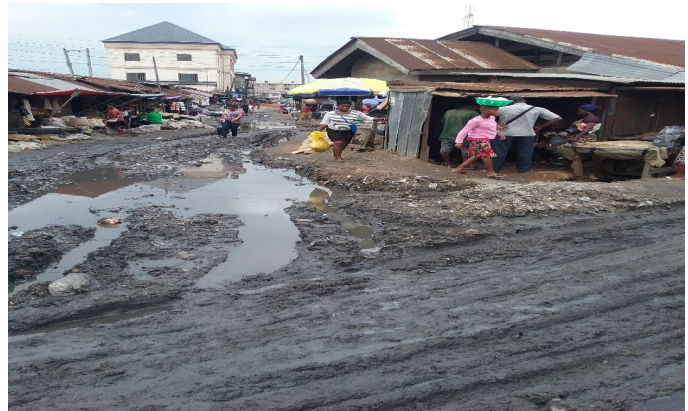
The roads within the immediate vicinity leading to the Substation (passing through the heart of a very, very busy market) are in a completely shambolic state and is a very important hub for trading/commercial activities.

Figure 33: Puddle of stagnated water within the Substation premise/Deplorable state of the road leading to the Substation.

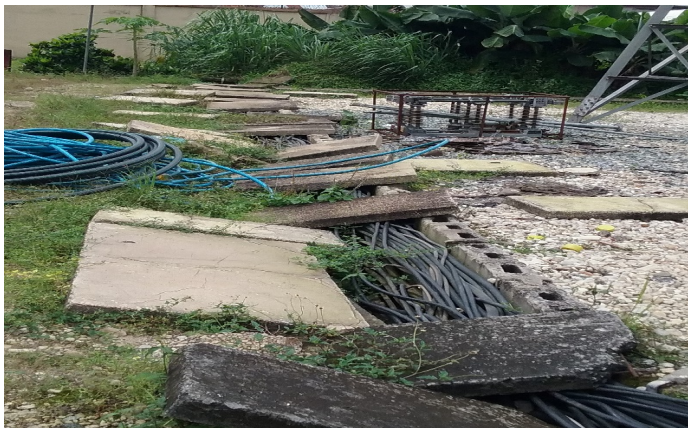
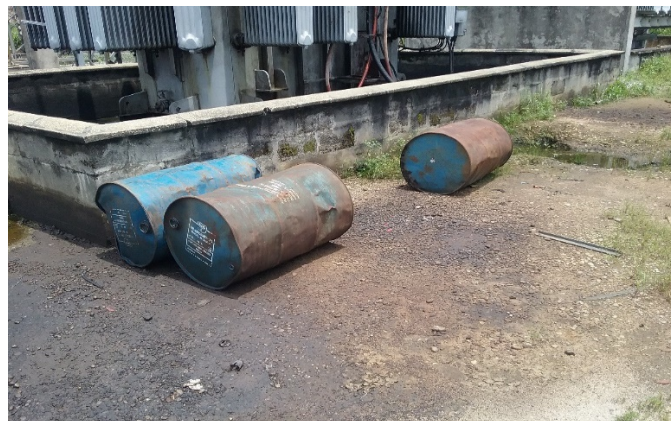
The substation switchyard floor is sparsely graveled and it is not properly maintained. Lightening in the switchyard (and the substation premise altogether) is not adequate and needs to be improved.

Figure 34: Broken/Collapsed trench cover slabs within the switchyard (posing potential injury risks Transformer Oil drums lying on the switchyard floor)

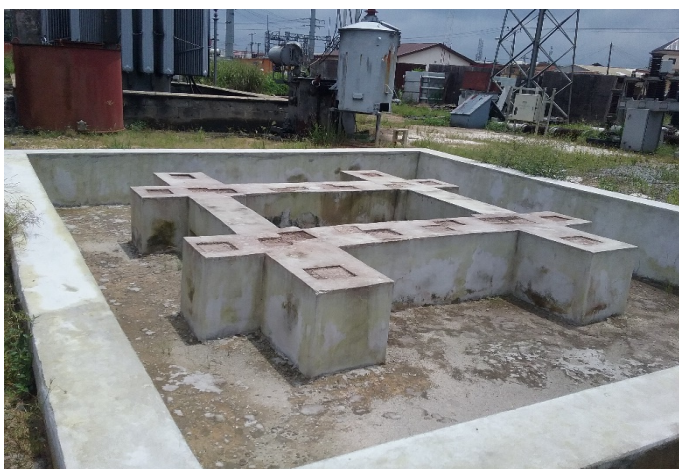
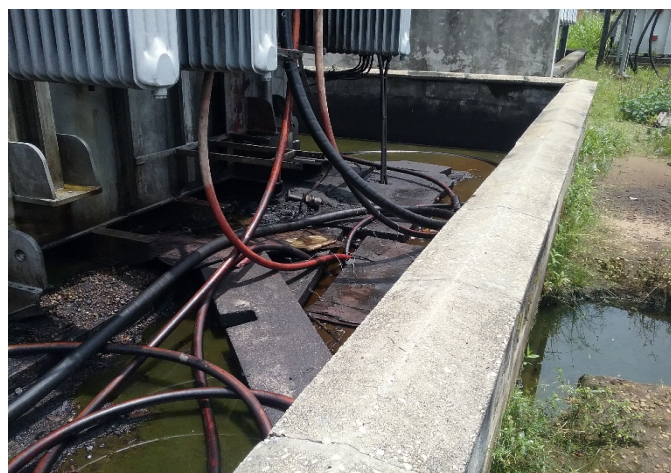
Figure 35: Transformer Plinth/Spilled oil from very old transformer(posing risks of ground-water pollution through seepage).

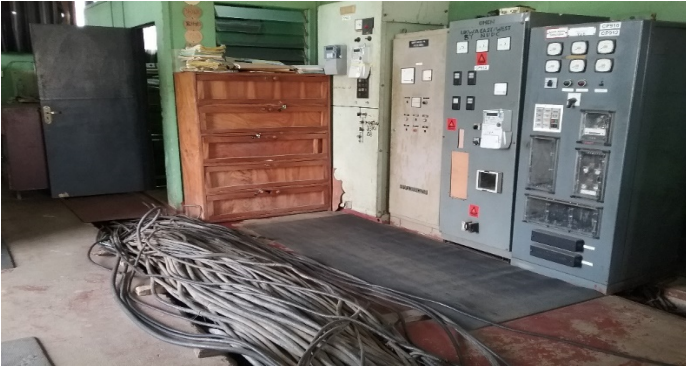
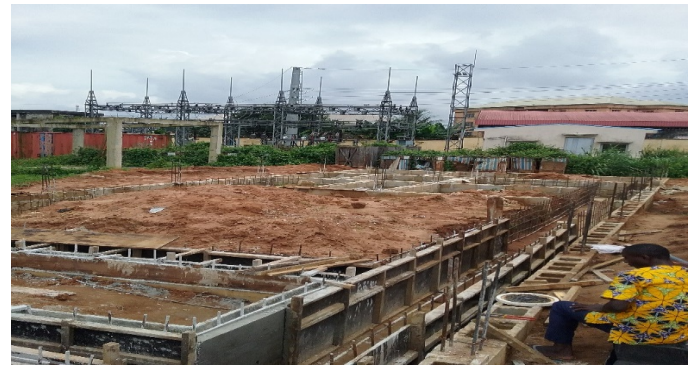
The Control room building is very old and decrepit and the working space is rather choked as there is barely enough working space for System operators, however there is an on-going construction of a new Control room under NEGIP.

Figure 36: Exposed cables in the Control Room blocking run-off along the cable trench/Foundation for new Control Room Building being laid.

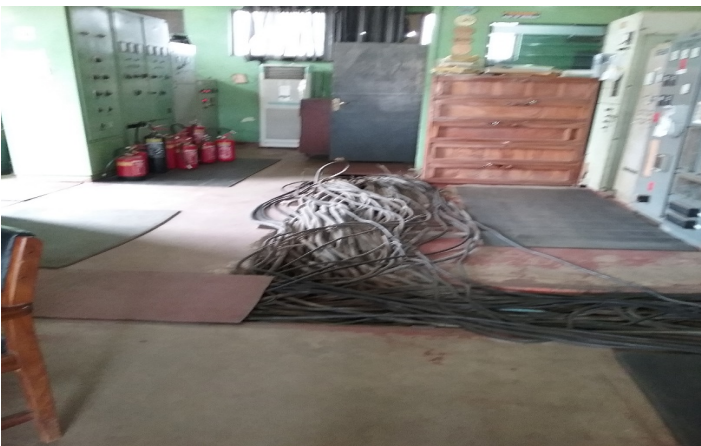
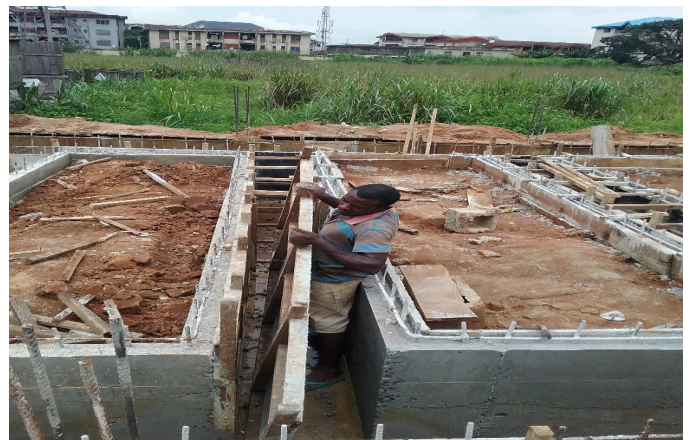
Figure 37: Fire Extinguishers at the Substation Control Room/Disregard for use of PPEs by Construction workers.

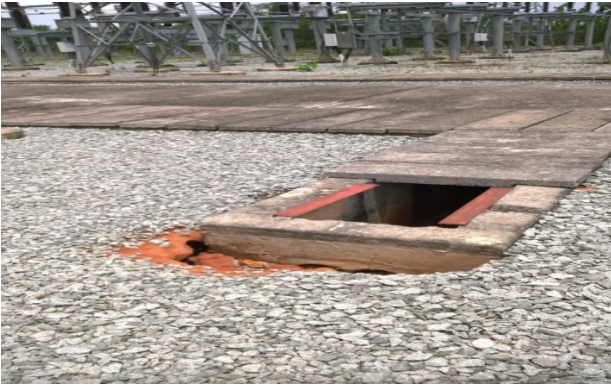
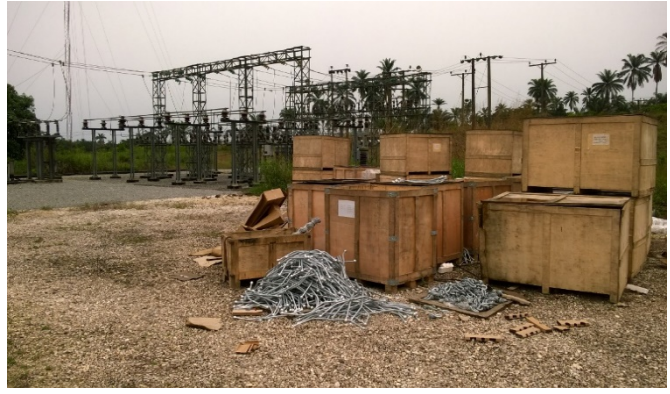
However, lightening in the switchyard (and the substation premise altogether) is not adequate and needs to be improved upon.

Figure 39: Erosion threat within the switchyard/Installation materials (from an on-going Project) in the switchyard (exposed to the vagaries of elements of weather and thefts).

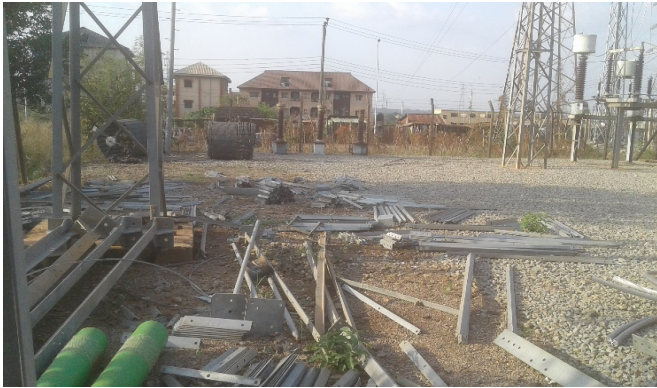
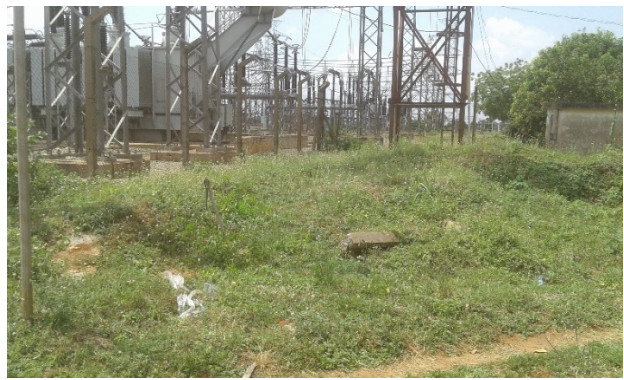
Figure 42: Poor storage of unused construction accessories/Dense Overgrowths within Substation premise.

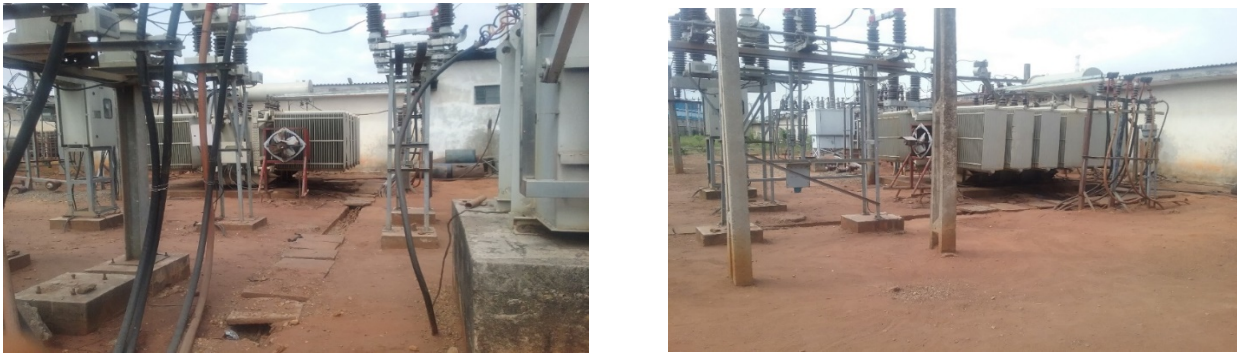
Figure 44: Blocked drainage channel resulting from sedimentation/ Switchyard properly maintained

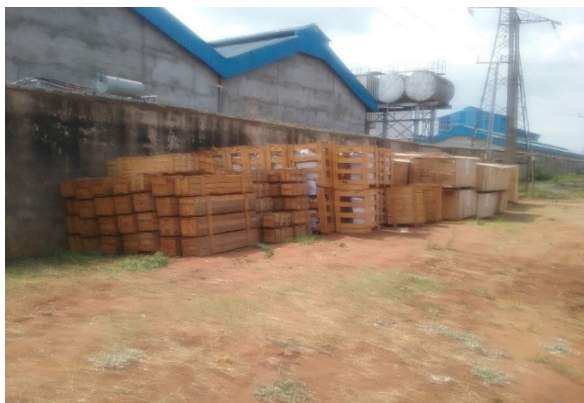
Figure 45: Construction materials neatly stacked but unprotected (leaving them susceptible to degradation, defectiveness or theft).

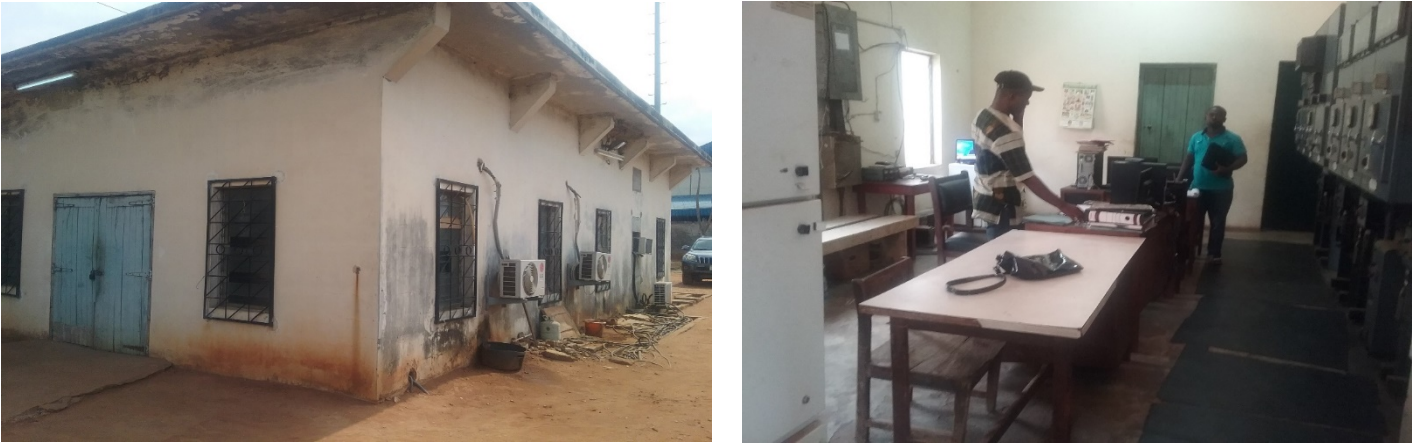
The existing building housing the Control Room is rather small, very old and poorly maintained and requires refurbishing and proper maintenance.

Figure 46: Very old and ill-maintained building structure housing the Substation Control Room/Decrepit furniture being use by operators.

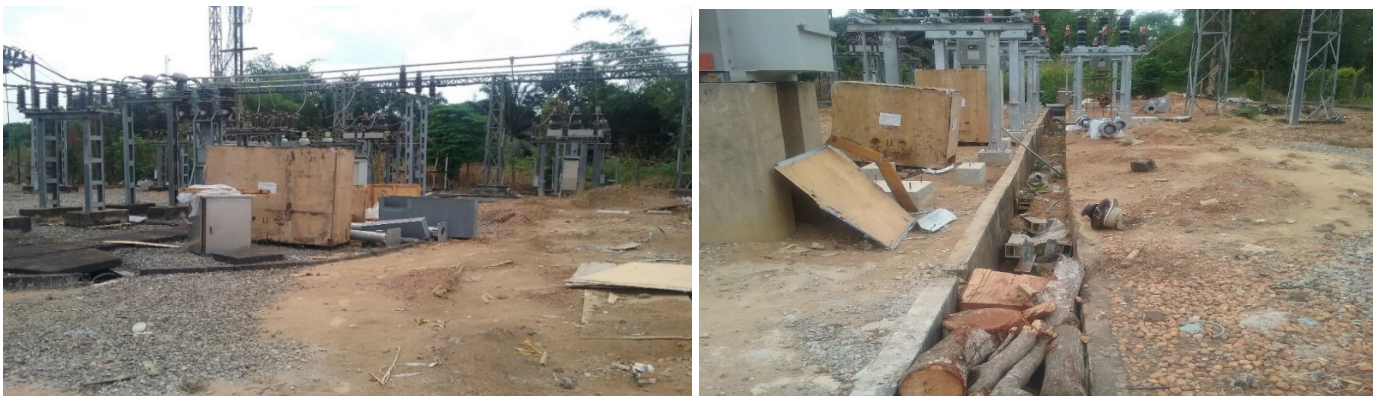
Figure 47: Equipment/materials and wastes littering the Substation premises/Blocked drainage channel resulting from sedimentation and dumping of waste.

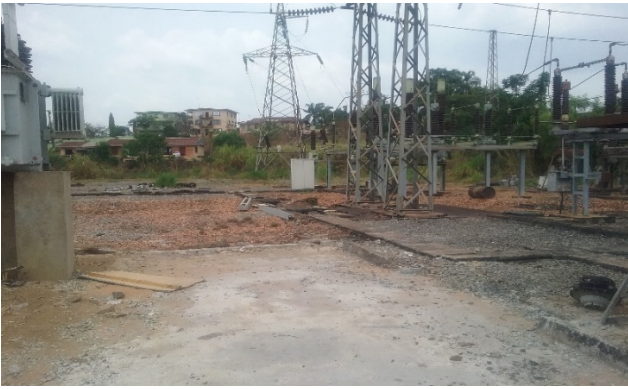
Figure 48: Scantly gravelled Switchyard floor/Scrap (asbestos) generated from on-going Rehab works at the Substation.

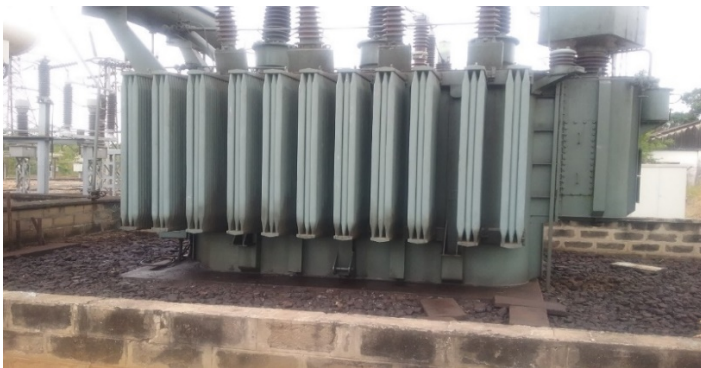
Figure 49: Oil leakage at transformer base.

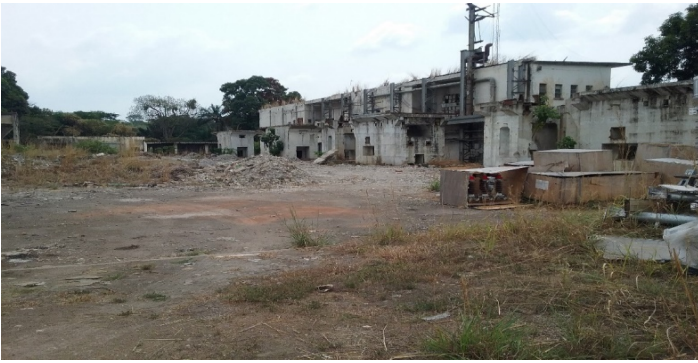
Figure 50: Very old and dilapidated building structure housing the Control Room for the Substation.

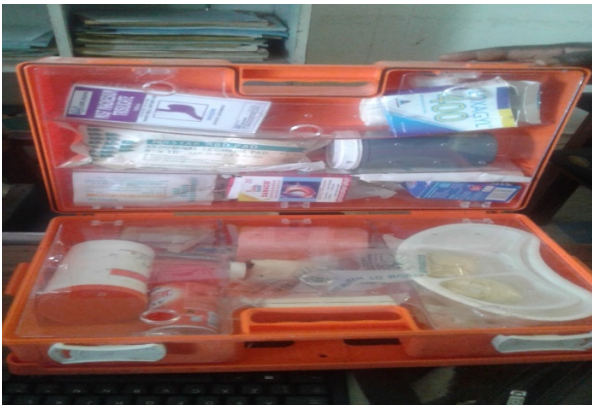
Figure 52: Sparse First Aid kits in the First Aid box at the substation/Old and weak office furniture available for use by operators.

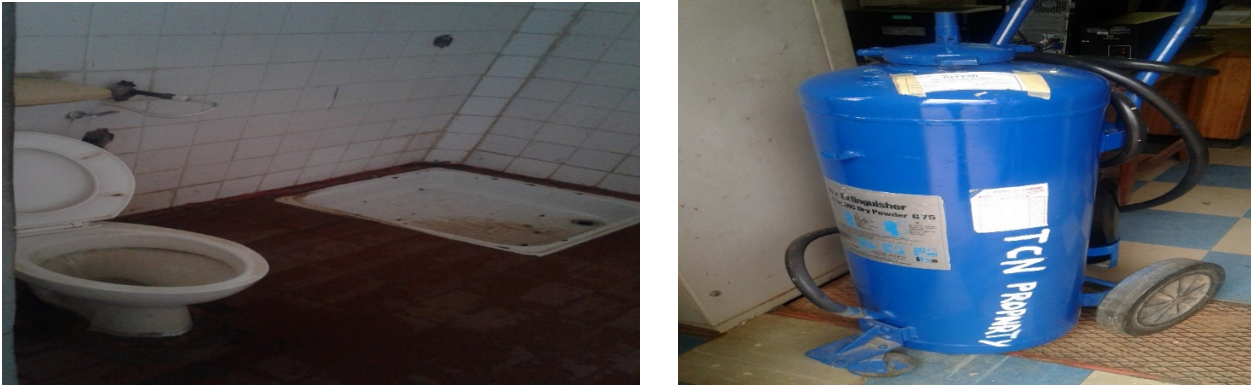
Figure 53: Restroom used by operators in a state of poor/Serviced fire extinguishers ready for deployment in the event of fire outbreak.
