Environmental and Social Management Plan (ESMP)

Rehabilitation/Reinforcement of 13No. Transmission Substations
(PACKAGE 2 LOT 1):

The proposed Nigeria Electricity Transmission Project
(NETAP).

Transmission Company of Nigeria (TCN)

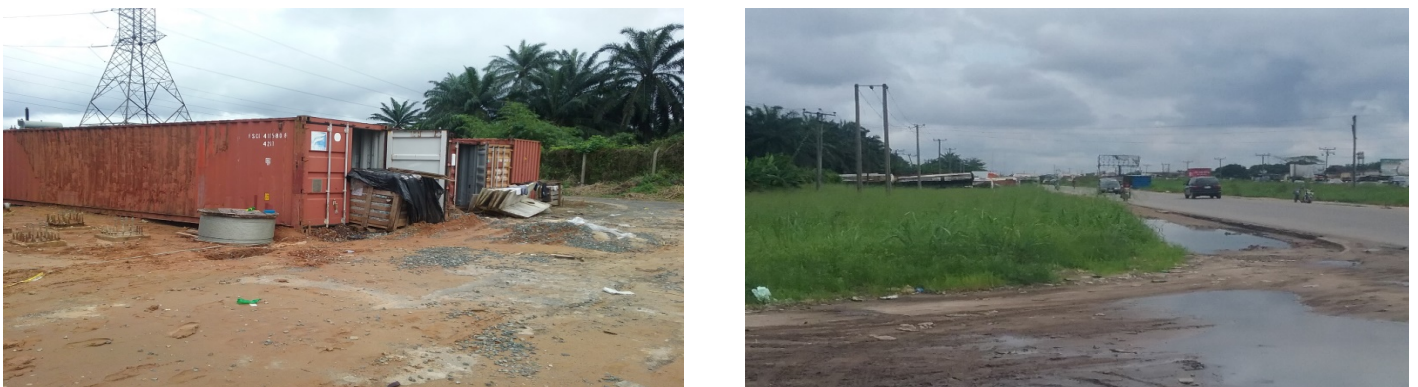
Figure 15: Containers used for storage of construction materials/Port Harcourt-Aba Road (leading to the Substation entrance).

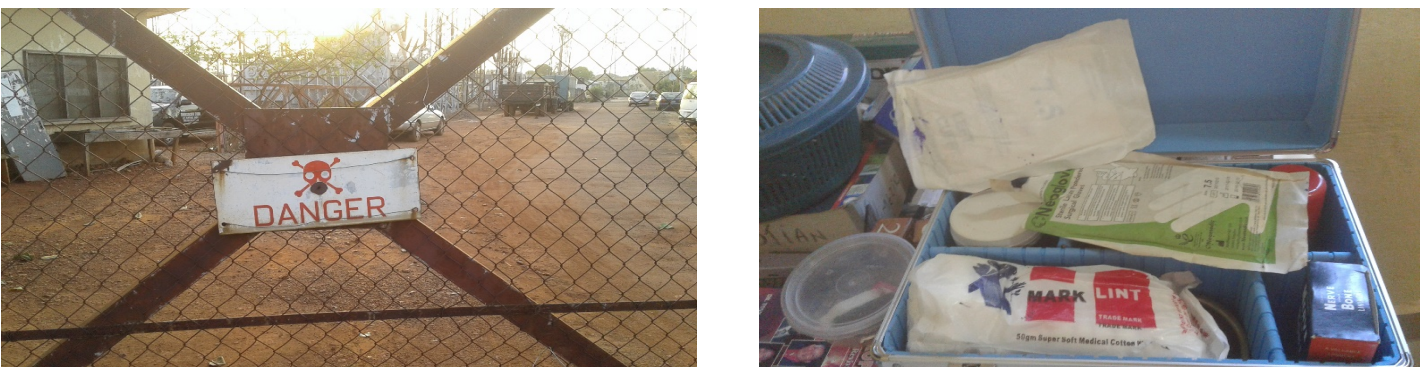
Figure 20: Existing (only) warning signage on Entrance gate to Substation premise/Substation First Aid Box application of weed control chemical.

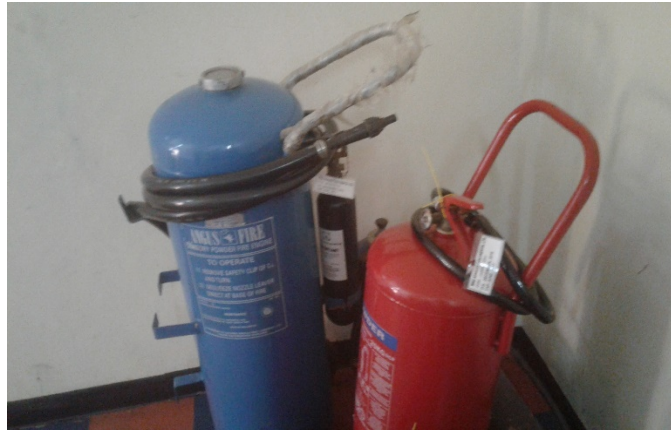
Figure 19: Fire Extinguishers at the Substation

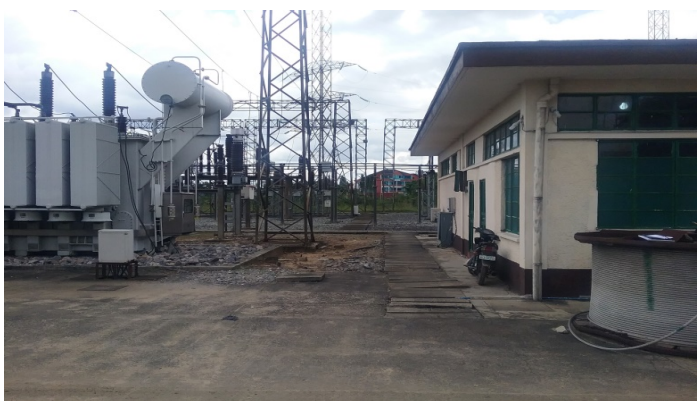
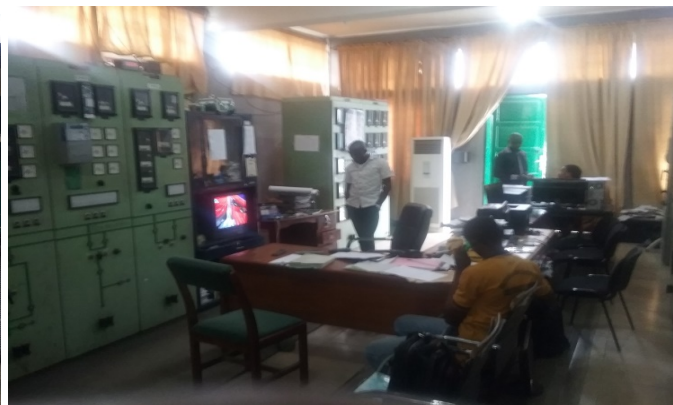
The Control room space for the 132/33kV Substation rather choked as there is barely enough working space for System operators.

Figure 23: Substation Control Room/Working area within Substation Control Room.

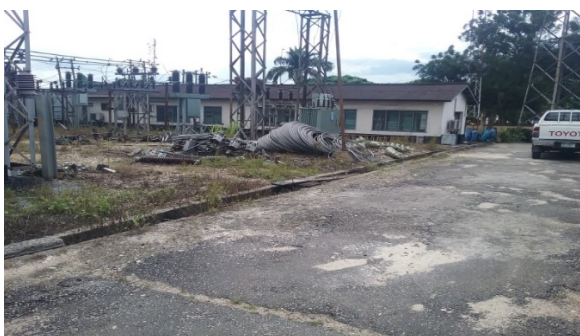
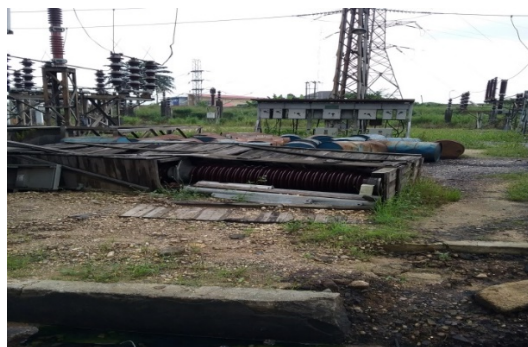
Figure 24: Decommissioned equipment littering the Substation premise/Poor storage of Construction Materials.

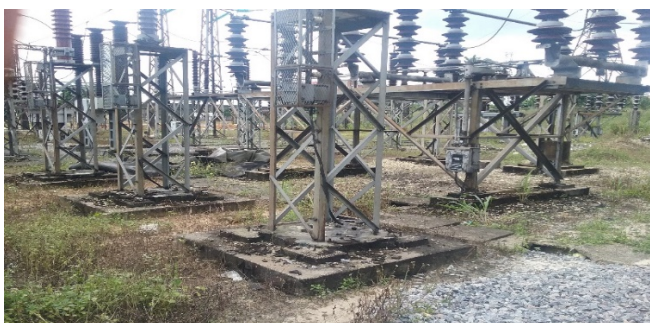
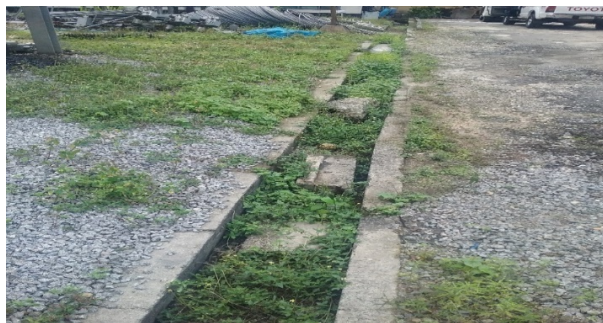
The flow of runoff through the drainage channels in the switch premises are hindered as a result of Sedimentation, Blockages by weed overgrowths and cables.

Figure 25: Overgrown weeds covering a significant part of the scantily graveled Switchyard floor/Overgrown weeds blocking drainage channels.

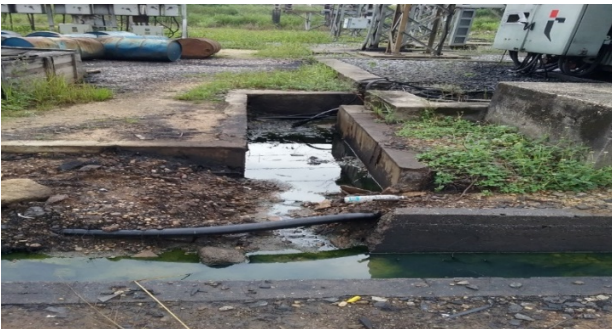
Figure 27: Spilled transformer oil trapped in stagnated water body (seepages have already affected the ground water supply).

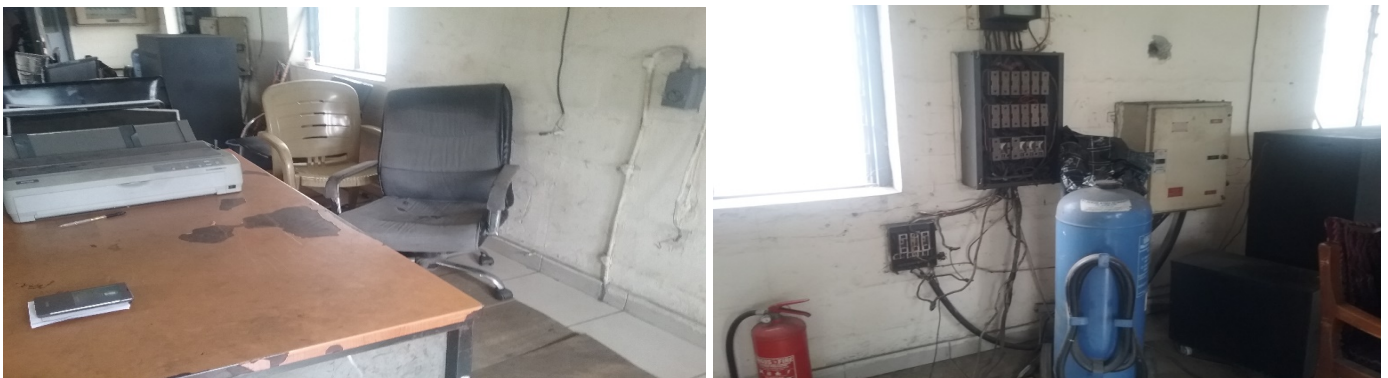
Figure 29: System Operators' Work area in the existing Substation Control Room/Fire extinguisher in Control room.

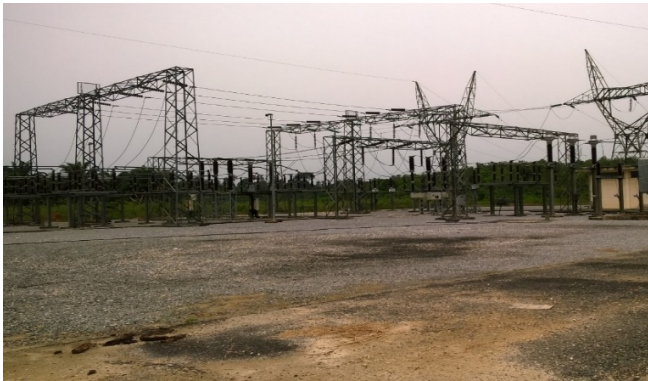
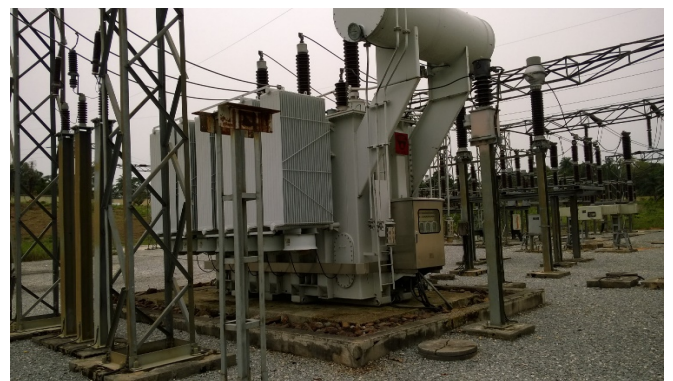
Figure 30: Itu 132/33kV Substation Switchyard/Existing 1x60MVA Transformer (No oil spillage noticeable)

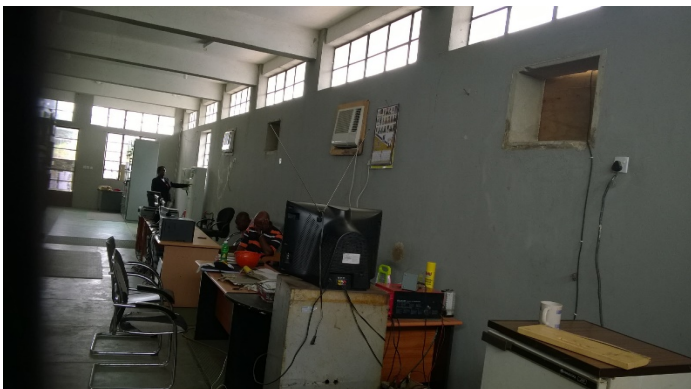
The ceiling of the Control room is leaking due to deterioration of the decking of the building.

Figure 31: The Control Room.

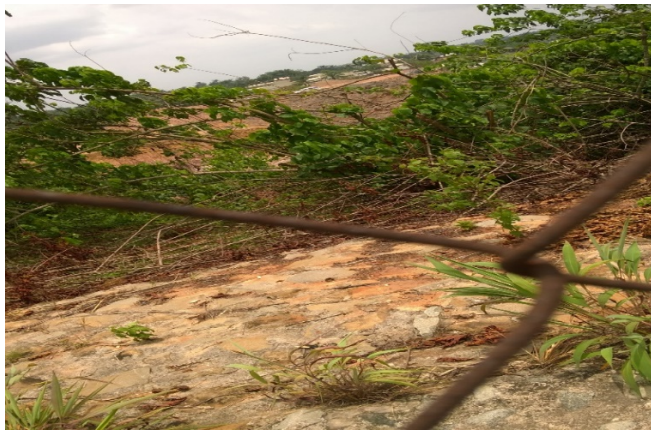
Also, the intense digging activities by prospector (searching for Kaolin – white coal) around (and within) the immediate surroundings/perimeter of the substation poses a grave threat to the foundations of structures within the substation.

Figure 38: Excavation activities on-going Outside the substation.

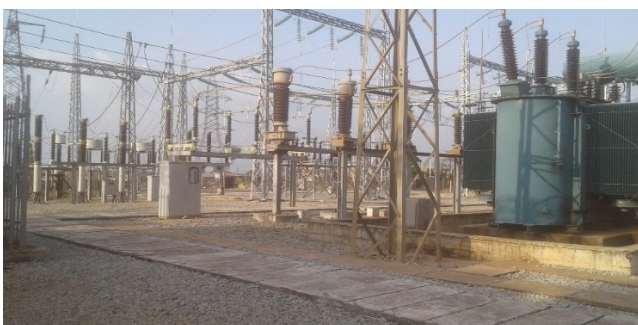
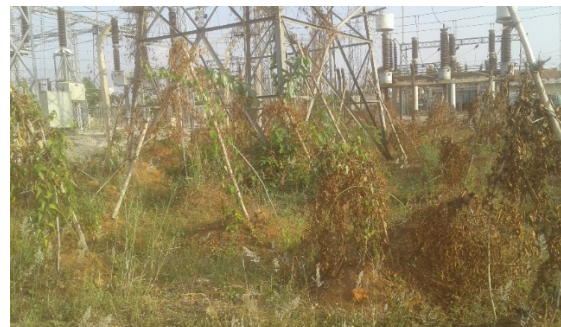
Figure 41: Adequately maintained switchyard floor/Farming activities within the Substation premise.

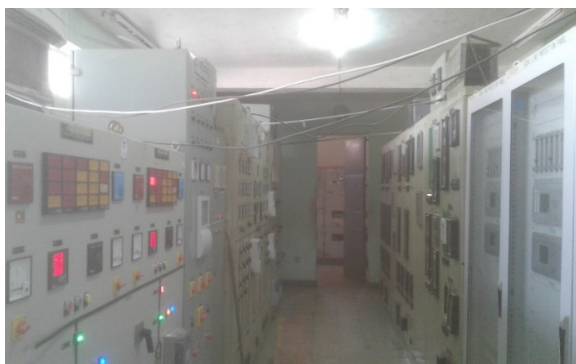
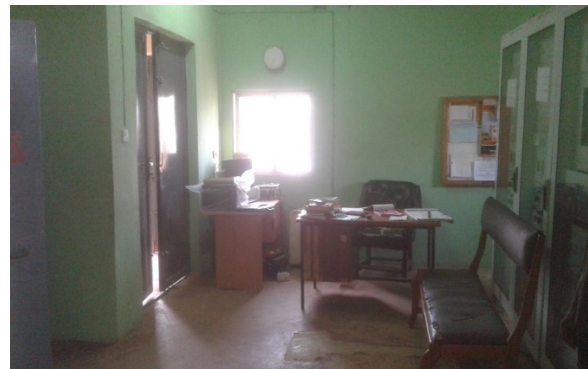
The Control Room building structure is old and require refurbishing and proper maintenance (the building is also shared with Ebonyi Electrical Distribution Company). Also, the Control room space is rather choked as there is barely enough working space for System operators and ventilation is very poor.

Figure 43: Control Panels in the Control Room/Working area within Substation Control Room.

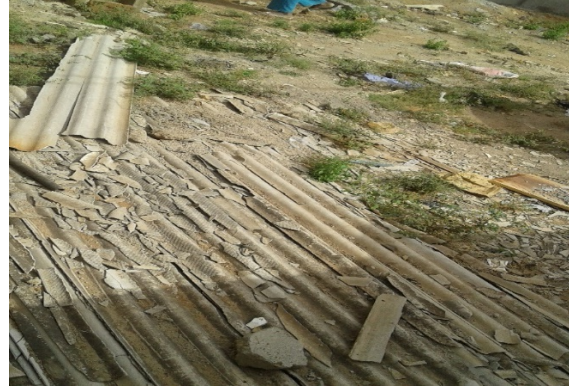
Figure 48: Scantly gravelled Switchyard floor/Scrap (asbestos) generated from on-going Rehab works at the Substation.

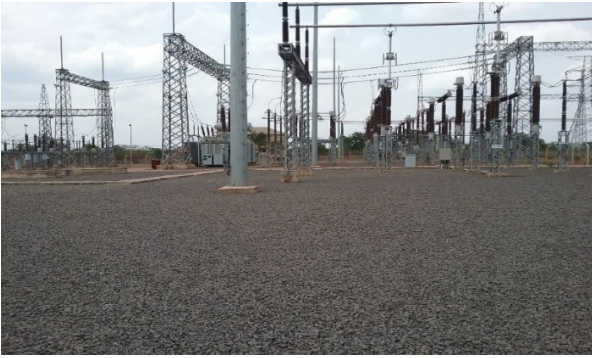
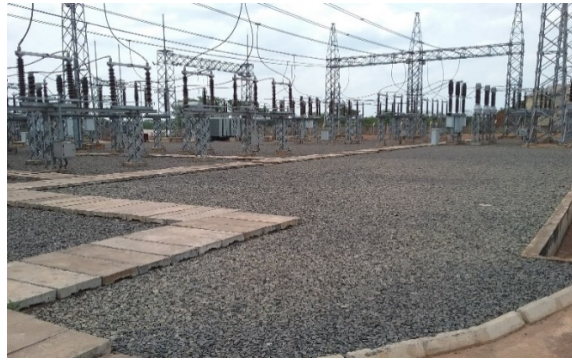
Some of the Cable trench covers slabs are intact (serving the protective purposes intended).

Figure 51: Properly maintained Switchyard floor/(well- gravelled and free of grasses or shrubs)/ Trench cover slabs intact, protecting power cables (eliminating the risks of accidental shock/electrocution).

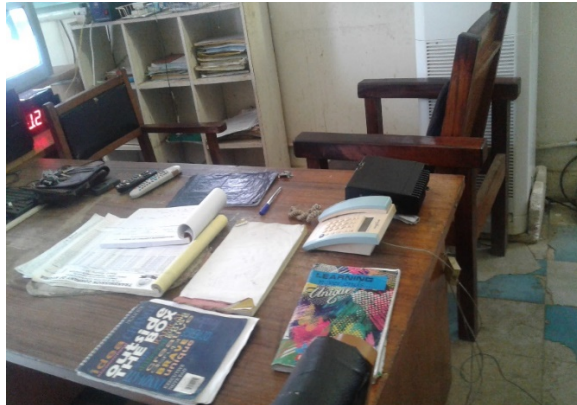
Figure 52: Sparse First Aid kits in the First Aid box at the substation/Old and weak office furniture available for use by operators.

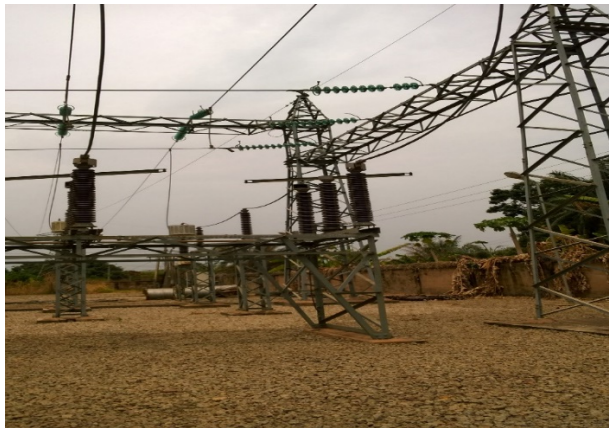
Lightening in the switchyard (and the substation premise altogether) is not adequate and needs to be improved.

Figure 54: Properly maintained Switchyard floor
